MERIT Solenoid

Work log – Tuesday April 24th

Solenoid test – building 180

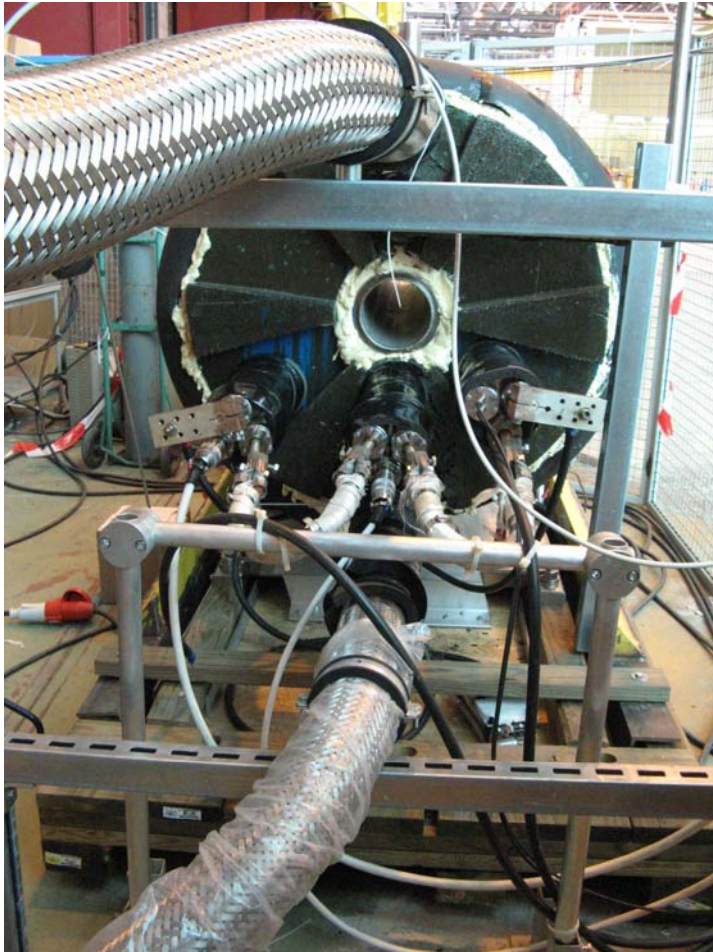
- Test setup
- During the cool-down done in week-16 LN leak was detected in the middle feedthrough and slight gas leak in the left feedthrough
- Extended icing prevented detecting the exact location of the leaks
- The magnet was then heat up to 324-337 K

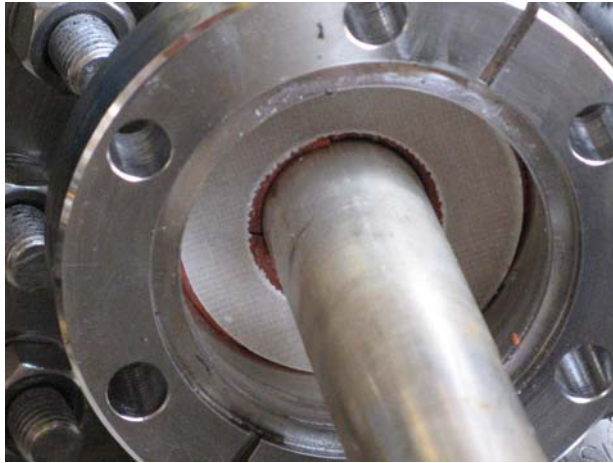
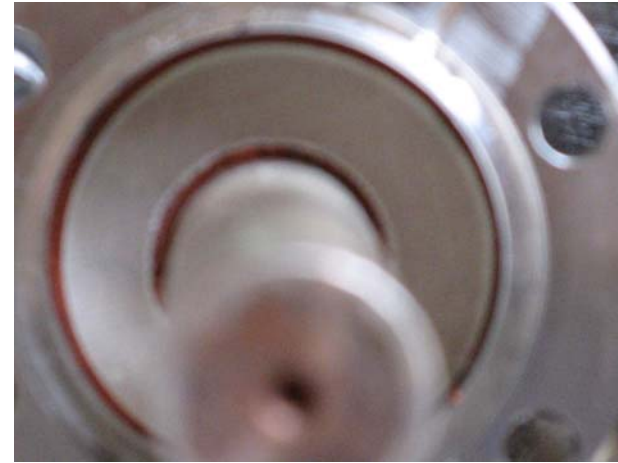
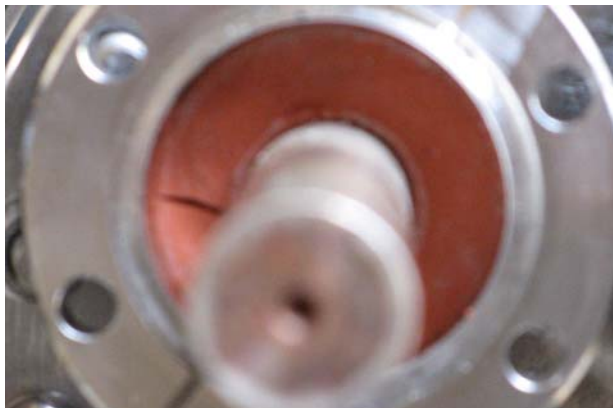
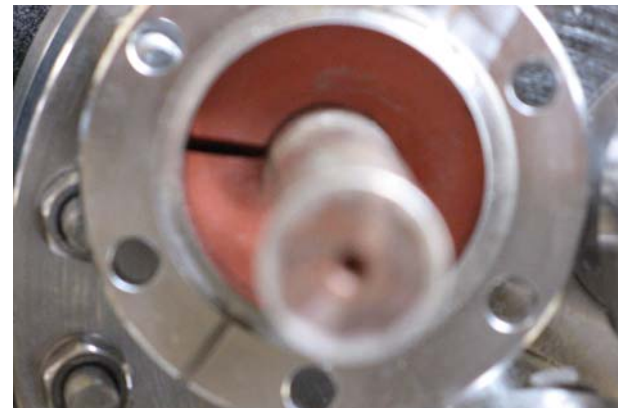
Middle feedthrough – left lead (2)

Taking out the G10 and looking at the first (left) and second (right) rubber ring

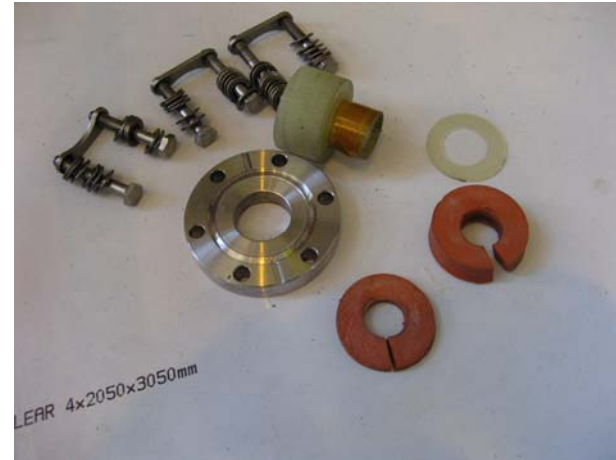
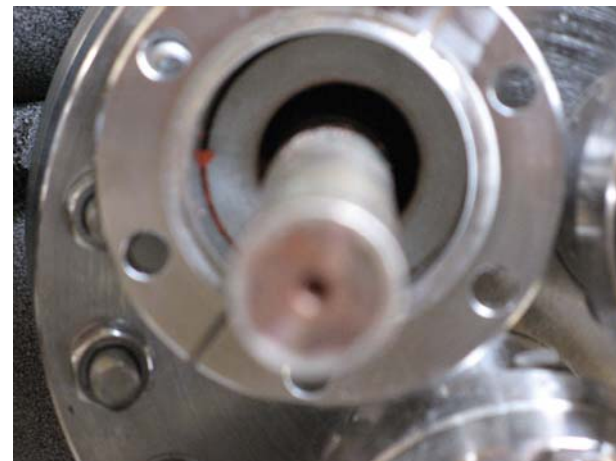
Middle feedthrough – left lead (3)

- The top picture shows all the material taken out
- Both rubber rings were broken, which I believe explains the observed leak.
- They are also quite hard and tend to brake easily.
- The current lead is well centered into the flange, and it was quite easy to remove everything without unscrewing the copper lead.

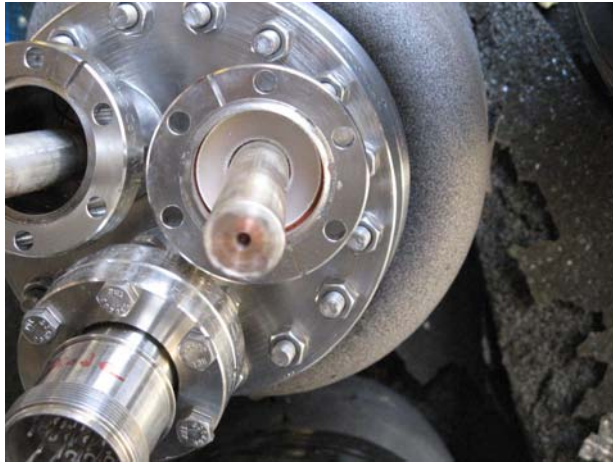
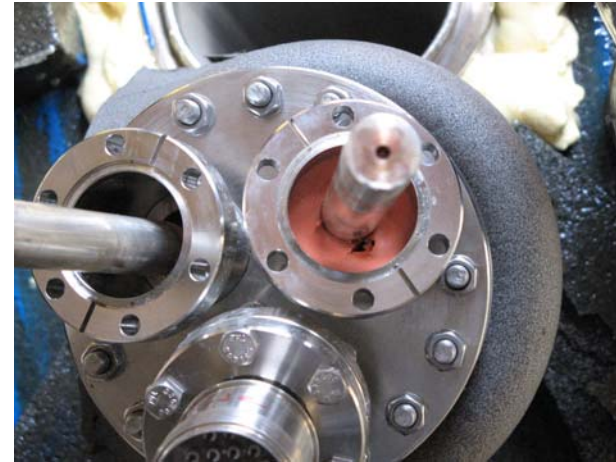
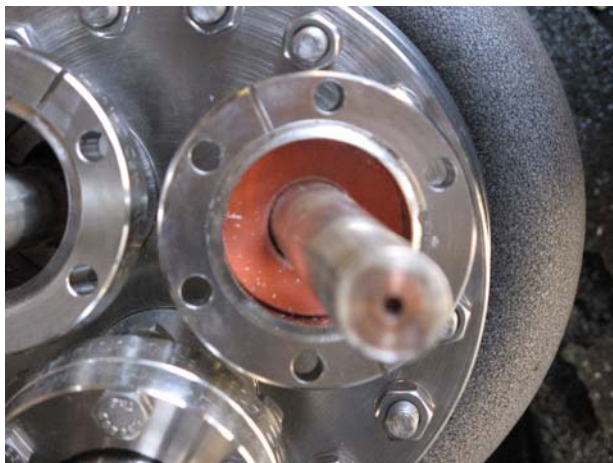
Middle feedthrough – right lead (1)

- Again the rubber ring has a hole in the inner radius
- However on the inner G10 ring it is well pushed inside the gap at the inner radius which provides the required tightness
- When everything was removed the current lead did not remain centered but was touching in the upper part

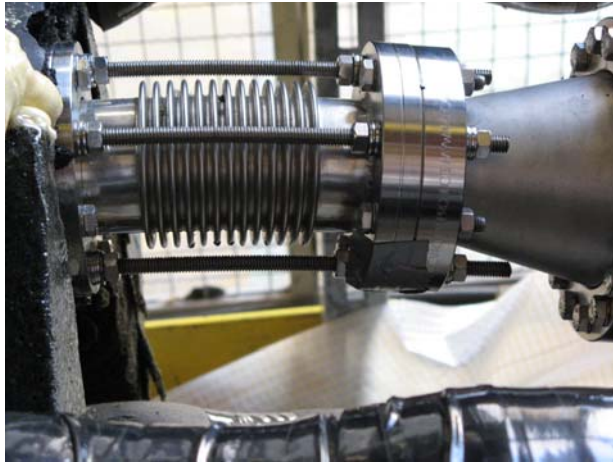
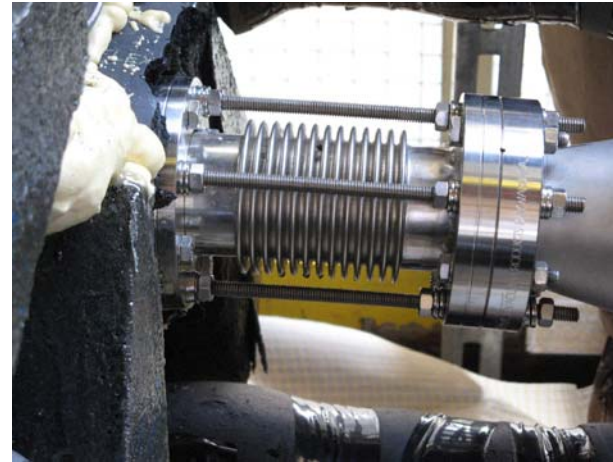
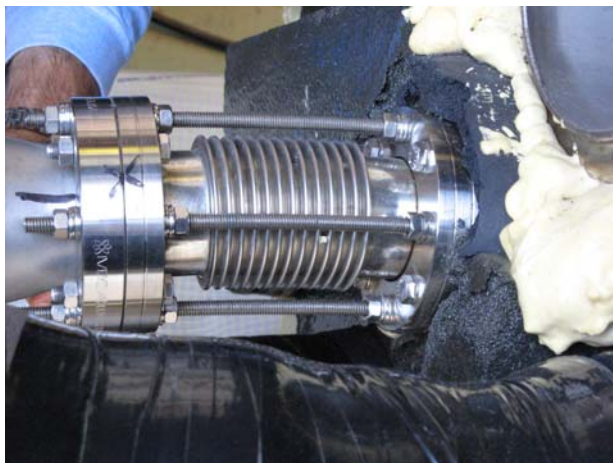
Correcting the bend in the middle feedthrough

- Unscrewing the outer nuts from the bottom long screws part of the bend was recuperated
- However afterwards from the current leads, the left one was touching up, while the right one was better centered – kind of the opposite situation we had before.
