# MERIT Installation at CERN

K. McDonald

For the MERIT Collaboration

April 13, 2007

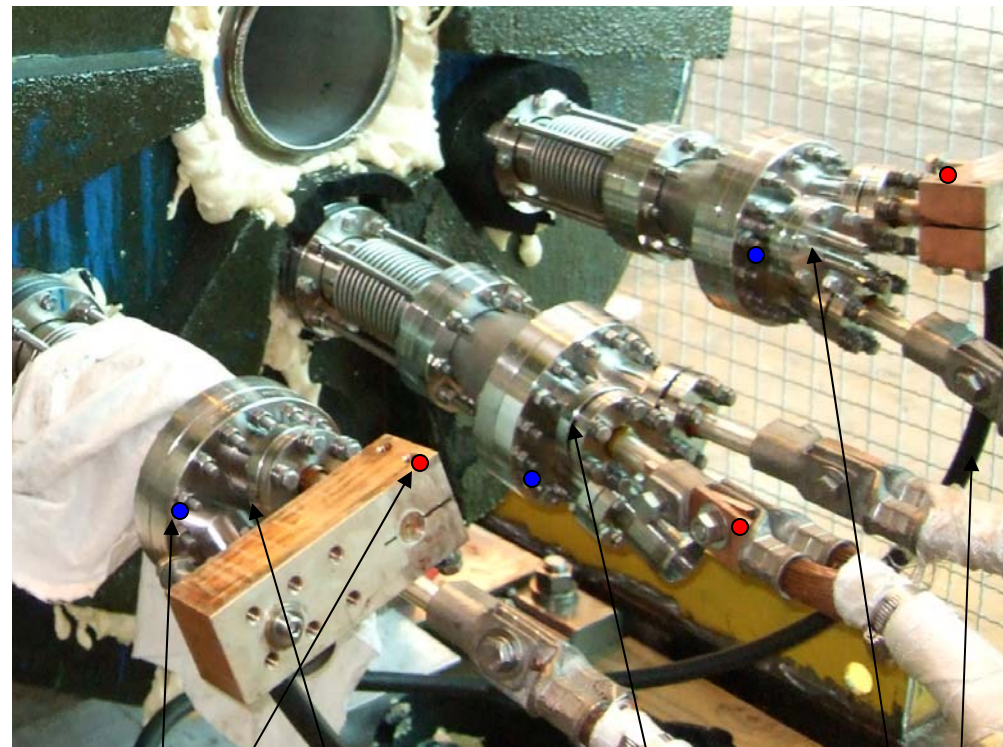
- Measure resistance between different points (I/V measurement). Slight bending of the middle coil might cause leakage current.
- Equipment:
  - Power supply: Caen N470
    - Current monitor at  $\mu\text{A}$  accuracy
  - Current meter: Keithley 2001
    - Tens of nA

Contact points  
Coil #1  
Coil #2  
Coil #3  
"Shorting cable"

Each coil  $\sim 100 \text{ G}\Omega$ , magnet  $\sim 30 \text{ G}\Omega$  (and "shorting cable"  $\sim 400 \text{ M}\Omega$ ).

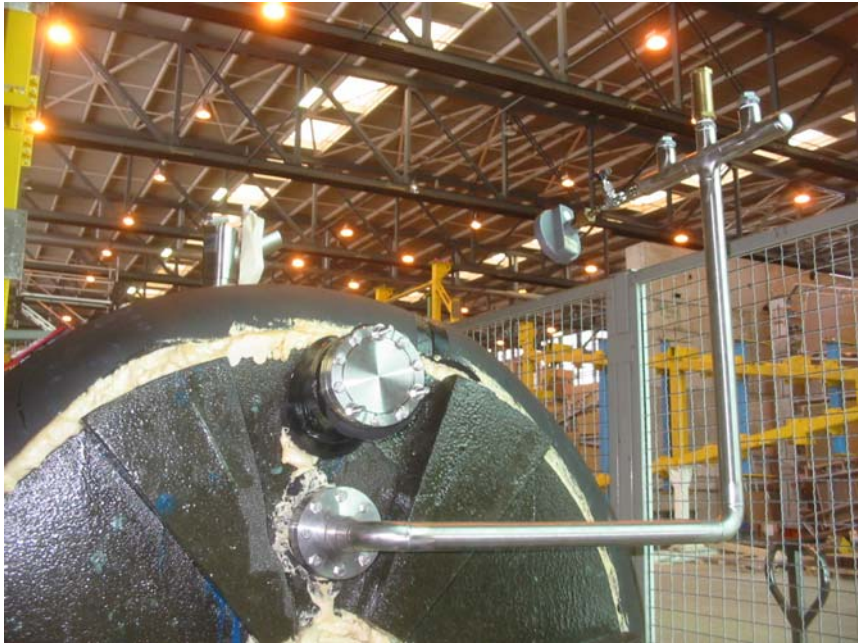
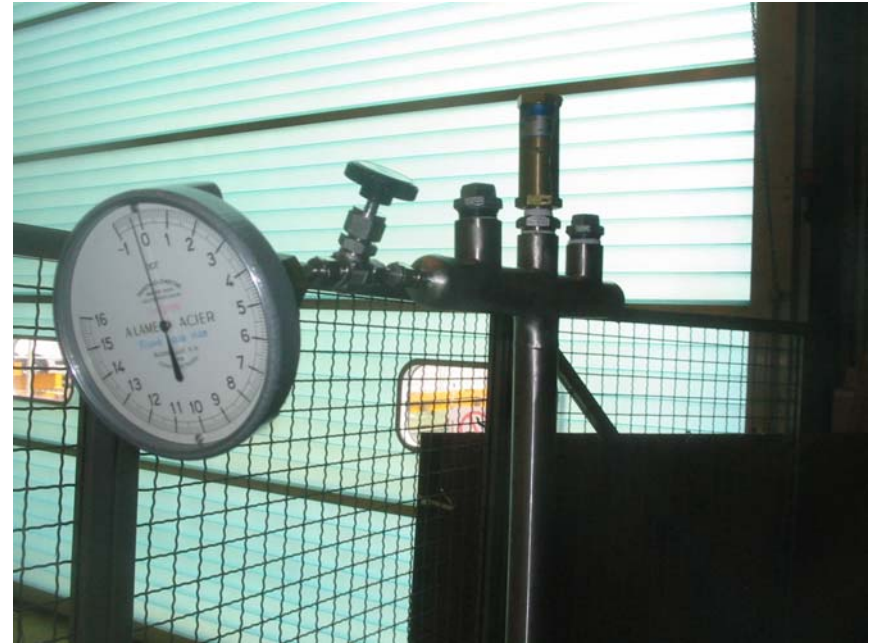
"Antler" of pressure relief valves added.  
Cryostat held 12.5 bar of He gas for 1 hour.  
No leaks detected with sniffer.

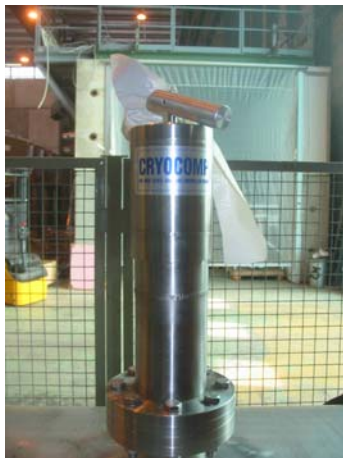
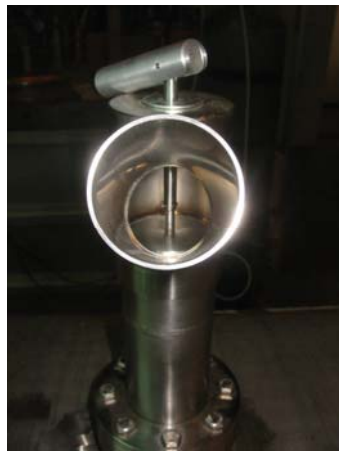
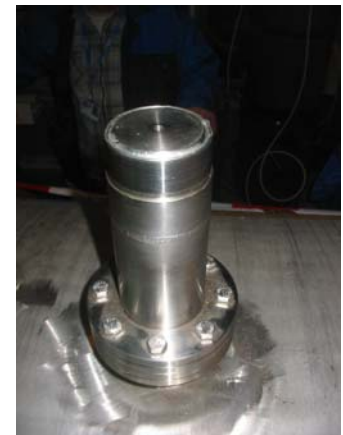
Cryocomp valve operator removed from vacuum jacket for proper operation of the pressure relief valve.

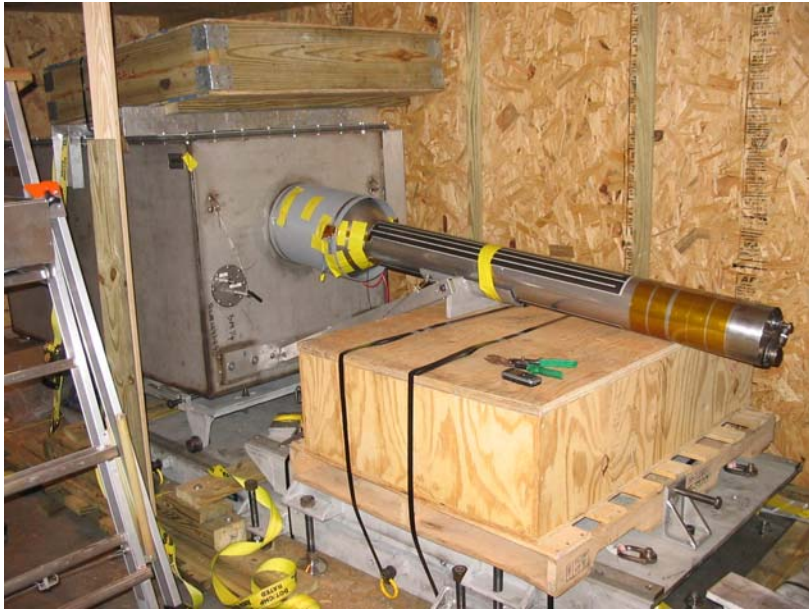
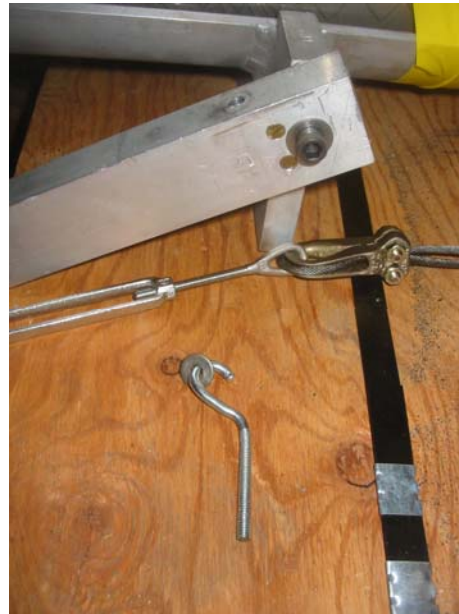
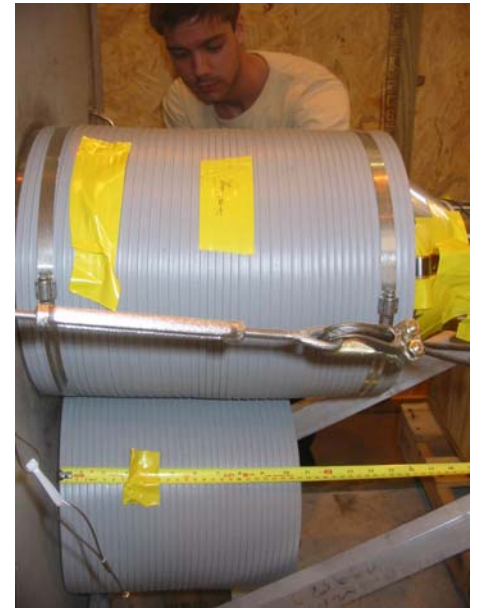
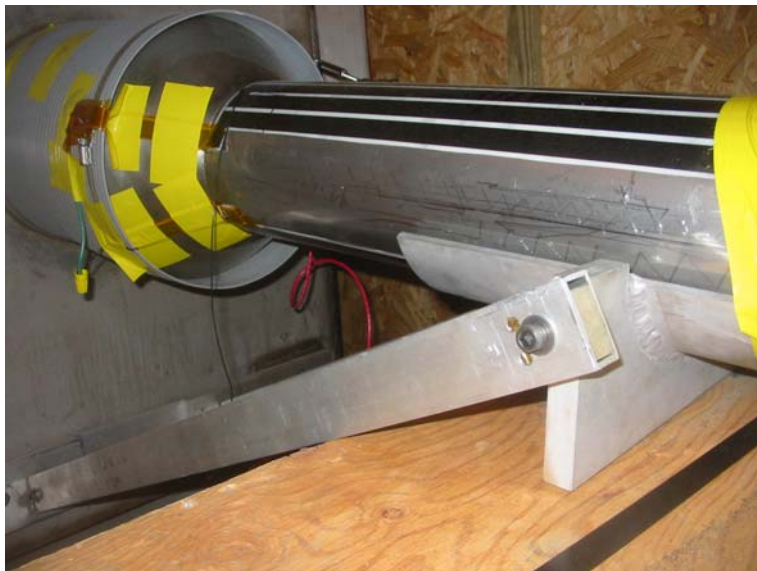
Mercury "Snout" Turnbuckles Worked Loose During Transport  $\Rightarrow$  Snout Fell 10 cm  
Rubber Collar Stretched by  $\sim 5$  cm.  
 $\hat{=}$  Damage to the Primary Containment?

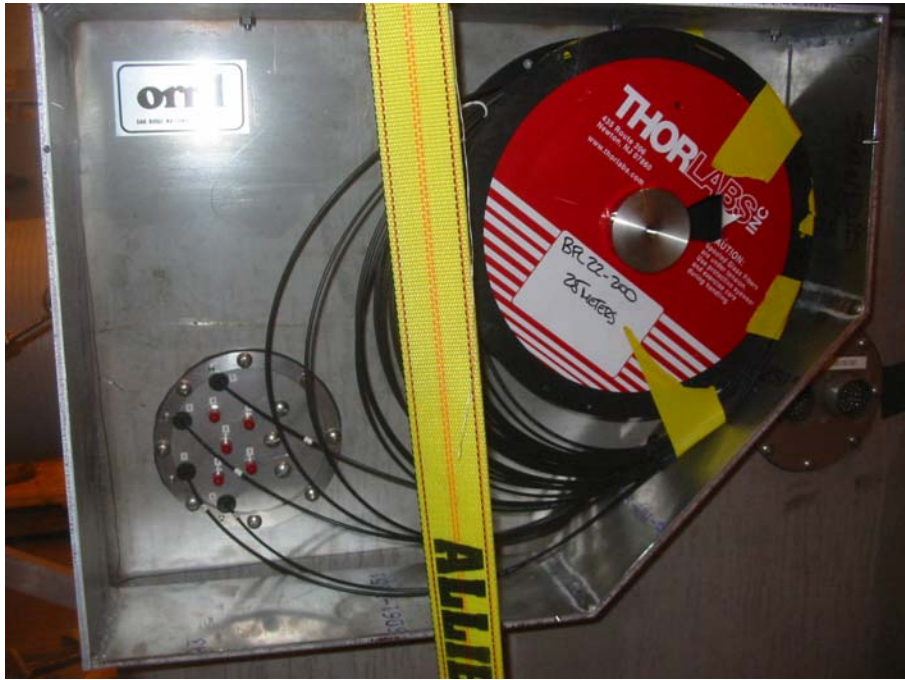
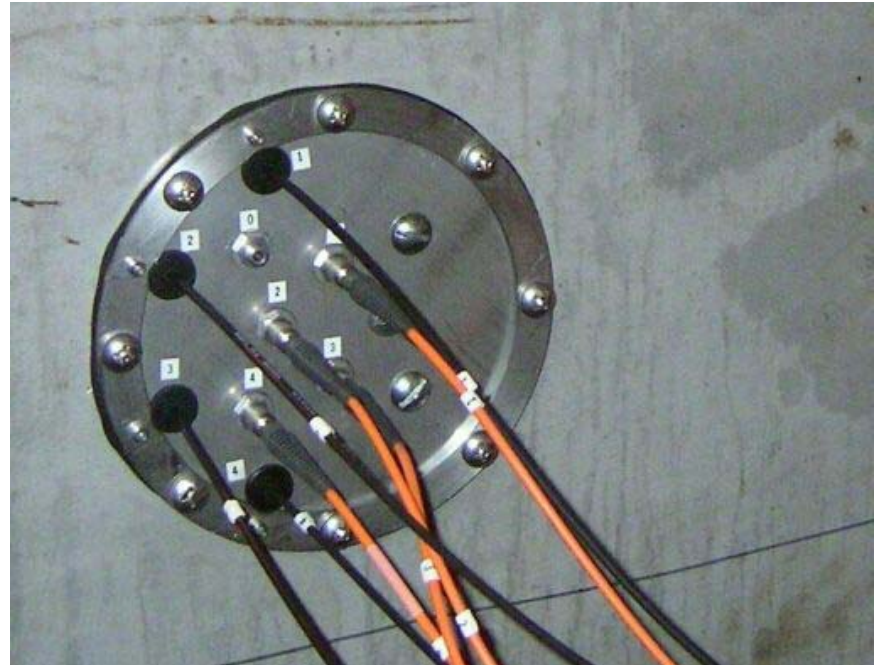
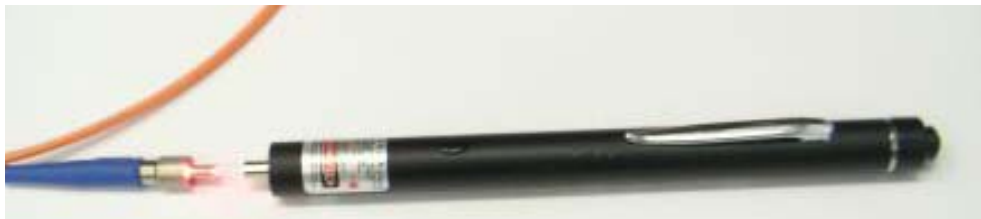
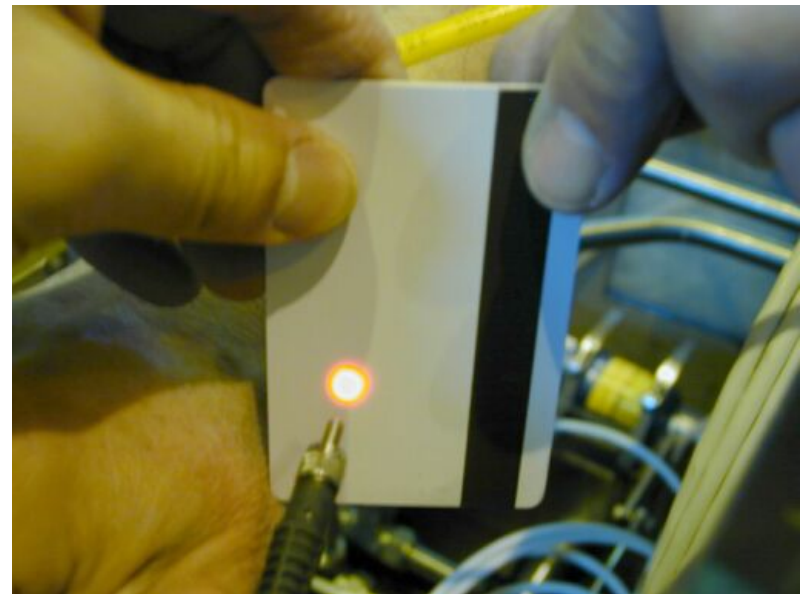
All fibers OK, tho image from fibers 1 and 3 less bright than those from 2 and 4.

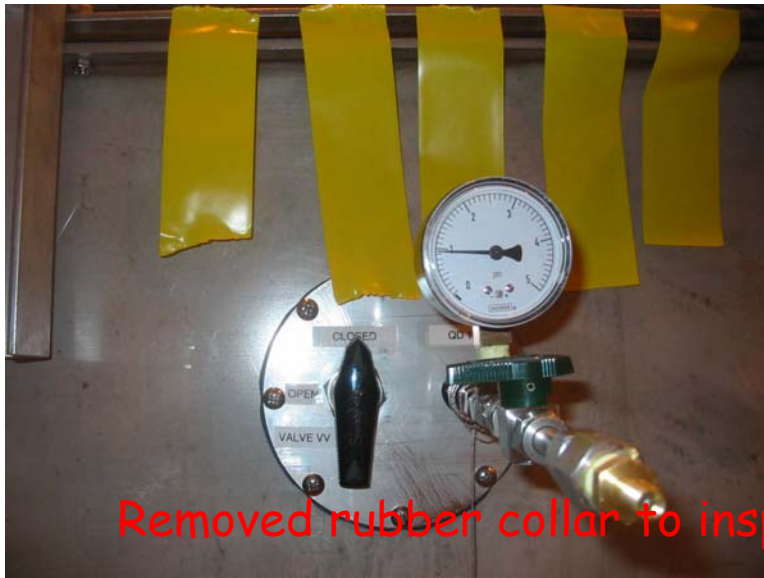
# Primary Containment Vessel Still Passes the 1-PSI Pressure Test

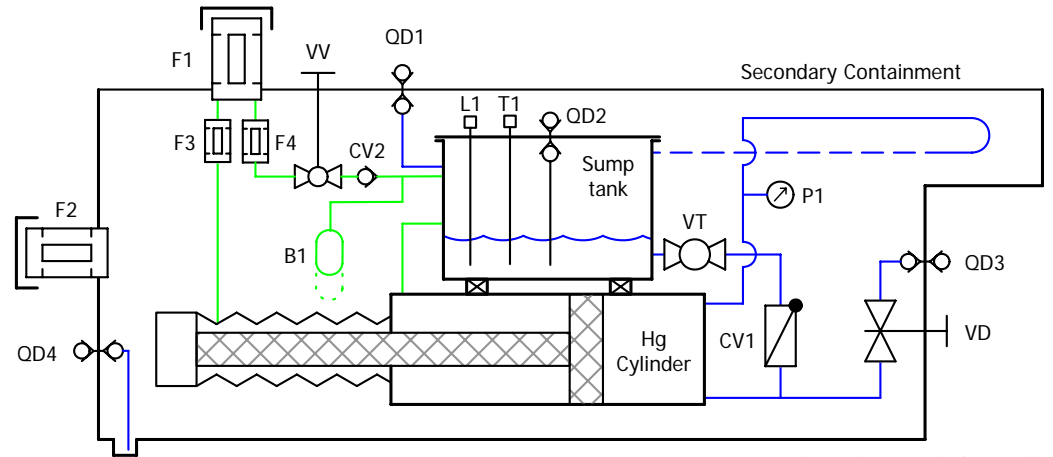
Removed rubber collar to inspect flexible Hg connectors. They still look good.
