Surface Inspection of the MERIT Primary Containment Chamber

*Van B. Graves
Oak Ridge National Laboratory
December 29, 2011*

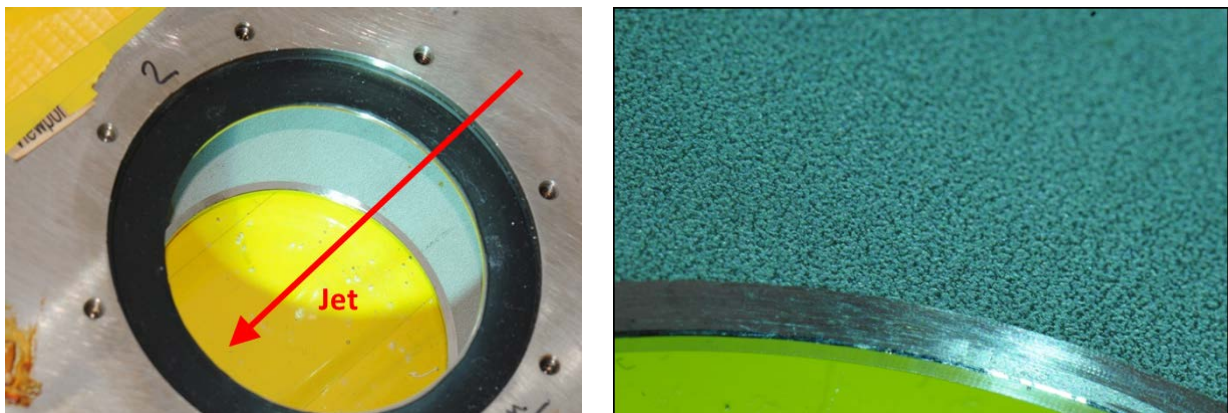
Figure 5 shows some representative photographs taken around viewport #2. These photographs show a surface texture which appears “rough,” and that texture could actually be felt by hand. When looking at the surfaces by eye, there was no indication of any changes in texture or surface pitting near any of the viewports, and the photographs seemed to bear this out.

To the personnel involved in the photographic inspection, who could directly view the surfaces, it was clear that there was a consistent surface finish throughout the entire chamber, which indicated that no significant surface damage had occurred during the experiment. However, this was not quite as obvious when the results were presented in Powerpoint slides since the photographs showed a textured surface

Figure 5. Viewport 2 close-up surface photos.

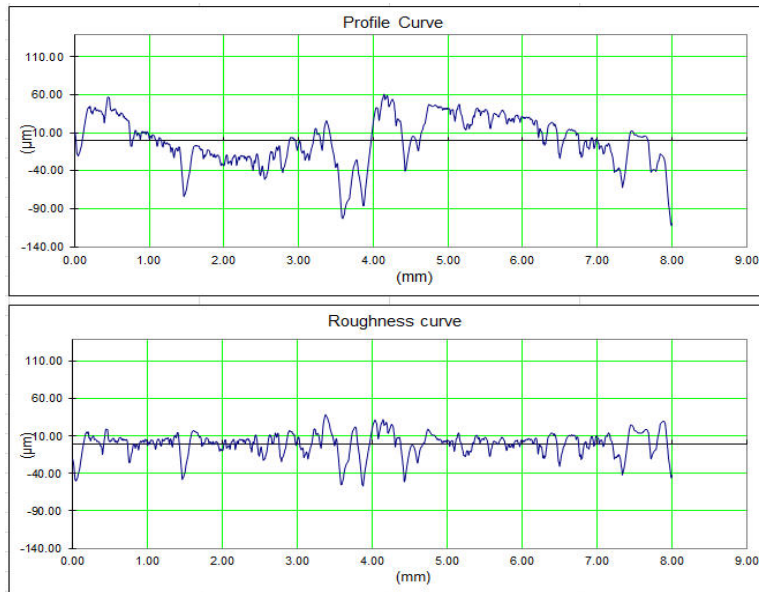
The Handysurf was used on four of the SNS samples, obtaining 7500 readings over an 8-mm sample length. The Handysurf software provide two separate plots for each scan, one giving an actual profile curve, and the other a roughness curve, which is the deviation from a least-squares fit through the profile data. In Figure 8, the measurement results of specimen 11 can be seen. Comparing the graphs

with the photograph in Figure 7, several of the large surface pits visible to the eye can be identified in the profile and roughness curves.

Figure 8. Surface scan results of SNS specimen 11.

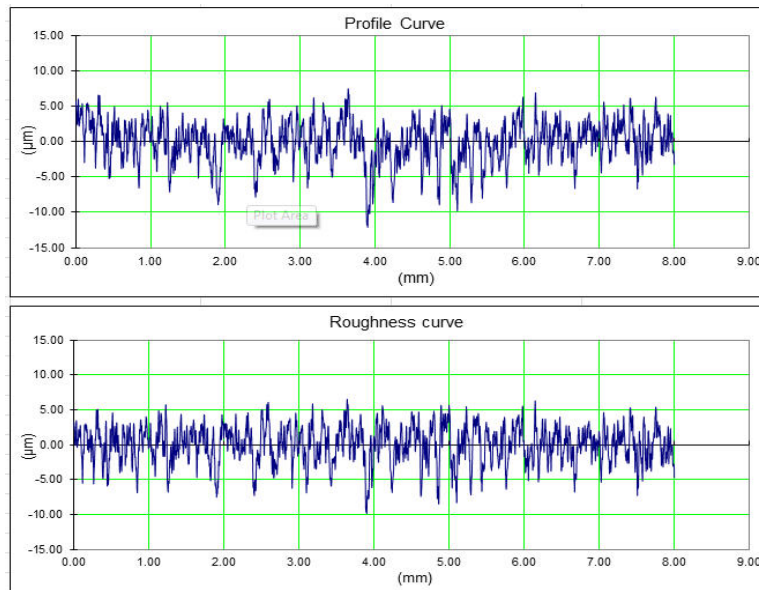
Figure 9 shows the results for specimen 14, which also had some visible surface damage. Comparing the vertical scales in Figures 8 and 9, it is noted the surface profile in sample 11 had a range of approximately 150 μm , whereas in the case of sample 14, the range was only 15 μm . It is also noted that while the surface irregularities in these samples are known to come from pits, it is difficult to distinguish actual pits in the curves.

Figure 9. Surface scan results of SNS specimen 14.

In the case of specimen 14, the roughness curve is similar to the profile curve due to the relatively flat overall surface geometry and does not offer any additional insight to the discussion. This was the case for most other scans, and therefore in subsequent figures, only the surface profile curves are presented.

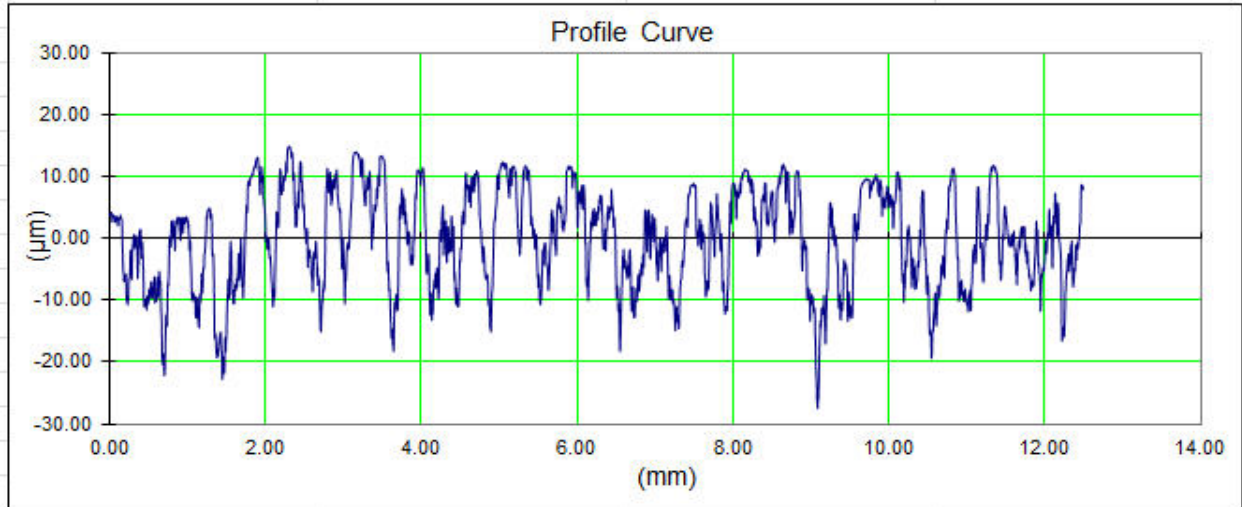
All the scans taken of the MERIT jet primary containment chamber are included in the Appendix. Of the most interest were the scans performed around viewport #2, which was centered on the jet/beam interaction location. Of the eight scans performed around viewport #2, scans 3 and 7 were along the beam axis and would be the most likely scans to show indications of surface damage. The profile curves produced from these scans are shown in Figures 13 and 14.

Comparing these profile curves with the photographs of viewport #2 shown in Figure 5, the apparent texture in the photographs can be observed in the scan data. It is also noted that the two curves are similar in that their deviation ranges are between $\pm 10 \mu\text{m}$, which indicates the same overall surface condition. A review of the other viewport 2 scans in the Appendix reveals very similar surface profile curves.

Figure 13. Scan P2_03 profile.

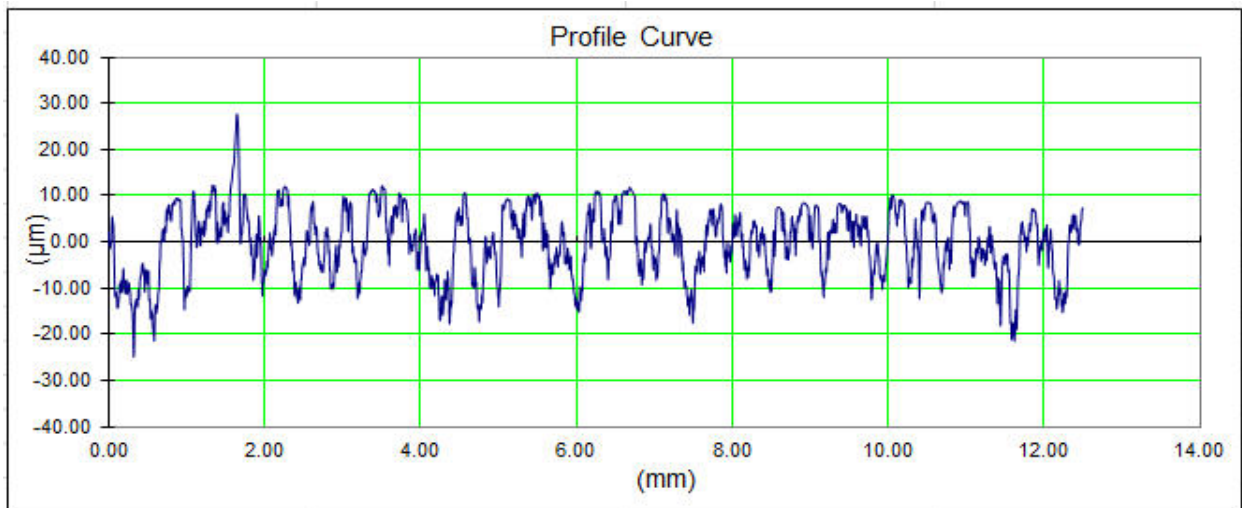
Figure 14. Scan P2_07 profile.

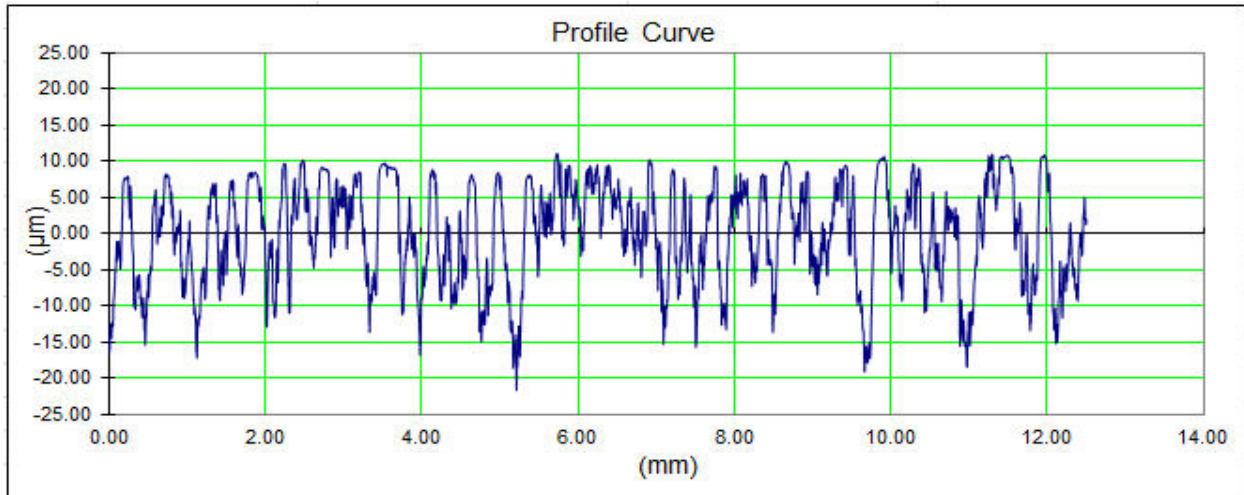
A more interesting observation can be made when the viewport #2 scans are compared to other locations on the same interior surface, which can be seen in Figure 15. From the scan map shown in Figure 11, it is seen that the R04 scan was taken downstream of viewport #4, well outside the area where any kind of damage-inducing droplets would be expected. It is noteworthy that no distinguishable differences exist between the scans around viewport #2 and this downstream location.

Figure 15. Scan R04 profile (interior surface).

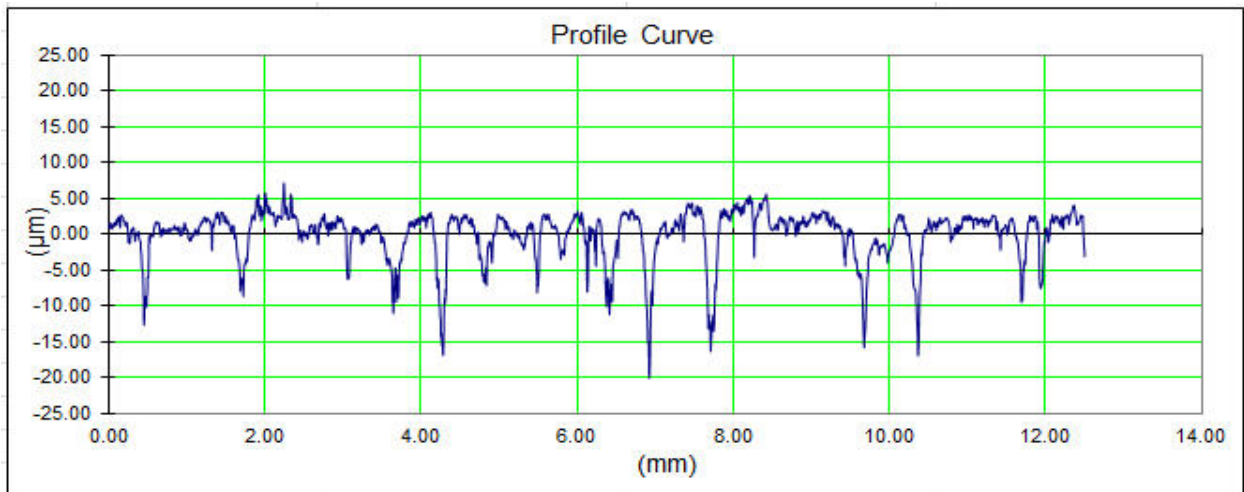
As another point of comparison, the profile from measuring an exterior surface of the MERIT chamber is shown in Figure 16. This surface was machined to final dimension, and the improved flatness of the surface can be seen in the figure. It is noted that even this machined surface shows local deviations of 10-20 μm , so even if mercury droplets could have impacted and damaged this surface, it would be

difficult to distinguish from surface imperfections. So the relative roughness of the interior surface is not surprising, considering it had no machining or other surface preparation prior to fabrication.

Figure 16. Scan R01 profile (exterior surface).
