MERIT Progress Report

Collaboration Phone Meeting

July 6, 2007

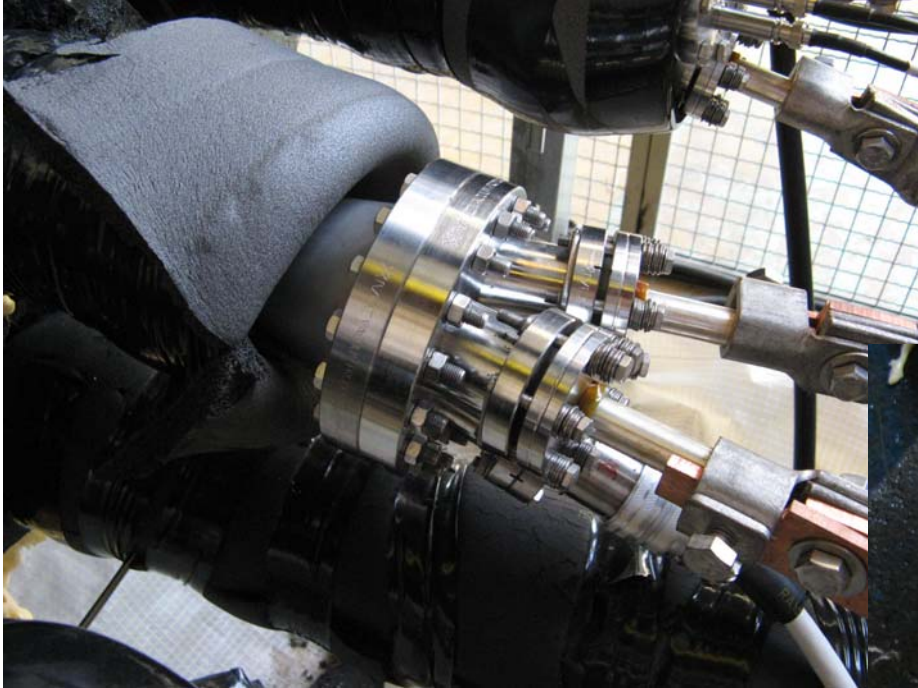
Solenoid Electrical Feedthrough

Source of the problem located

Radial cracks
observed in
several
silicone
packing
disks

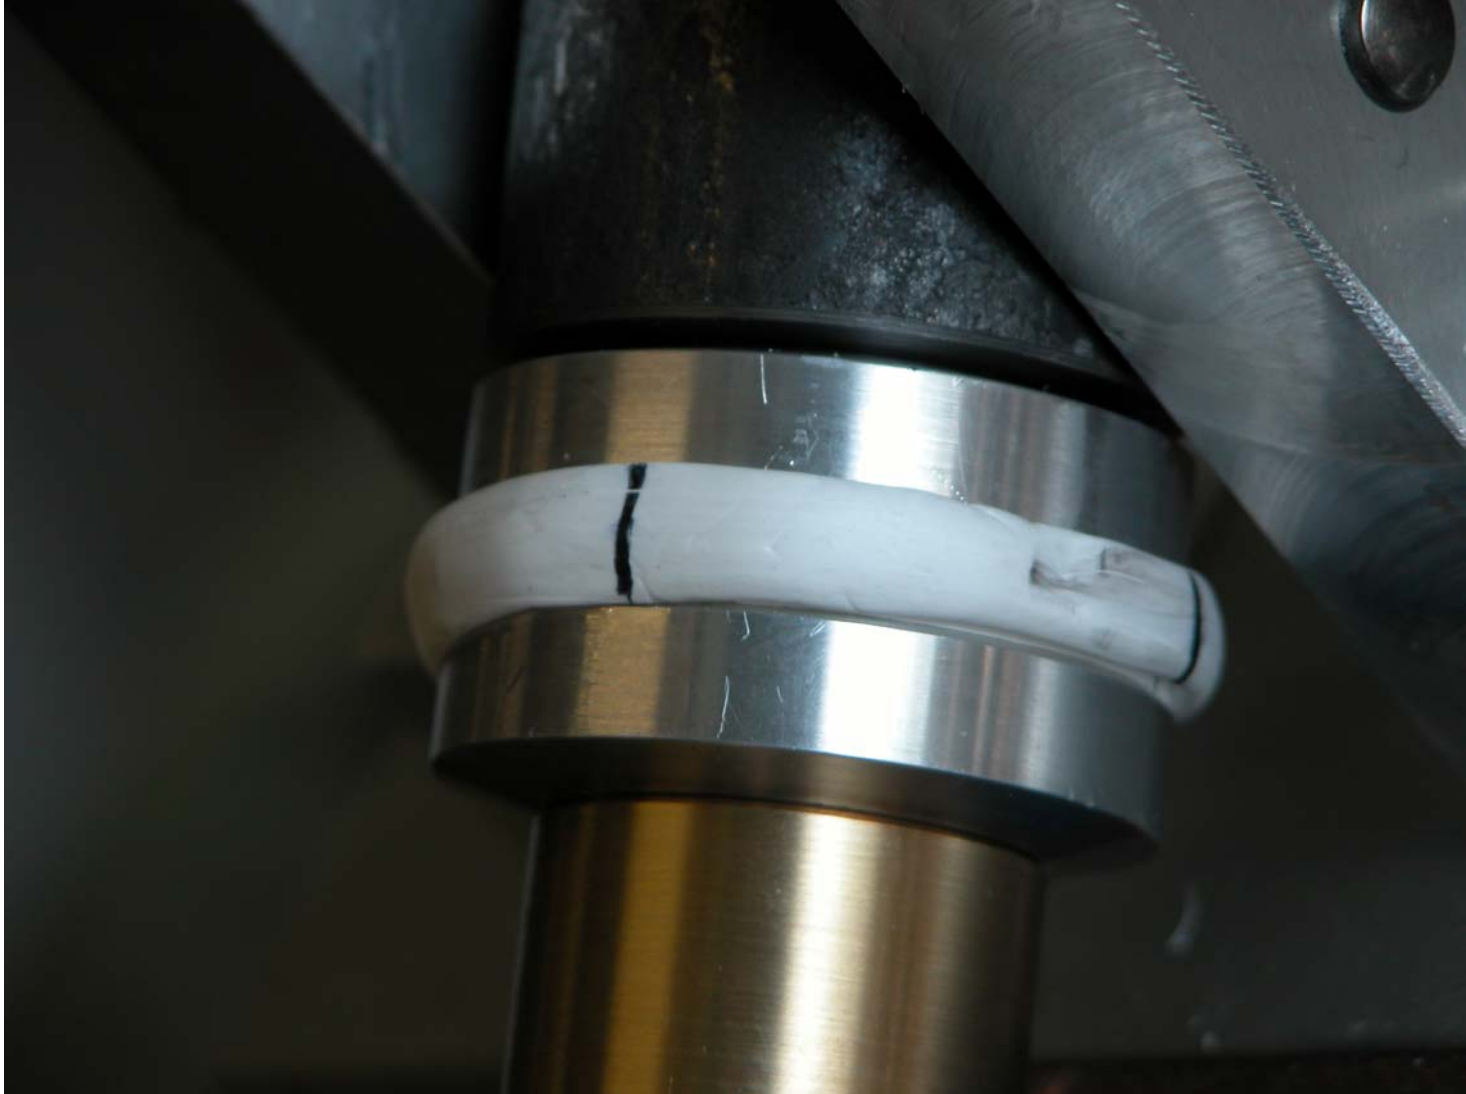
Compression Test with GoreTex

The GoreTex after compression

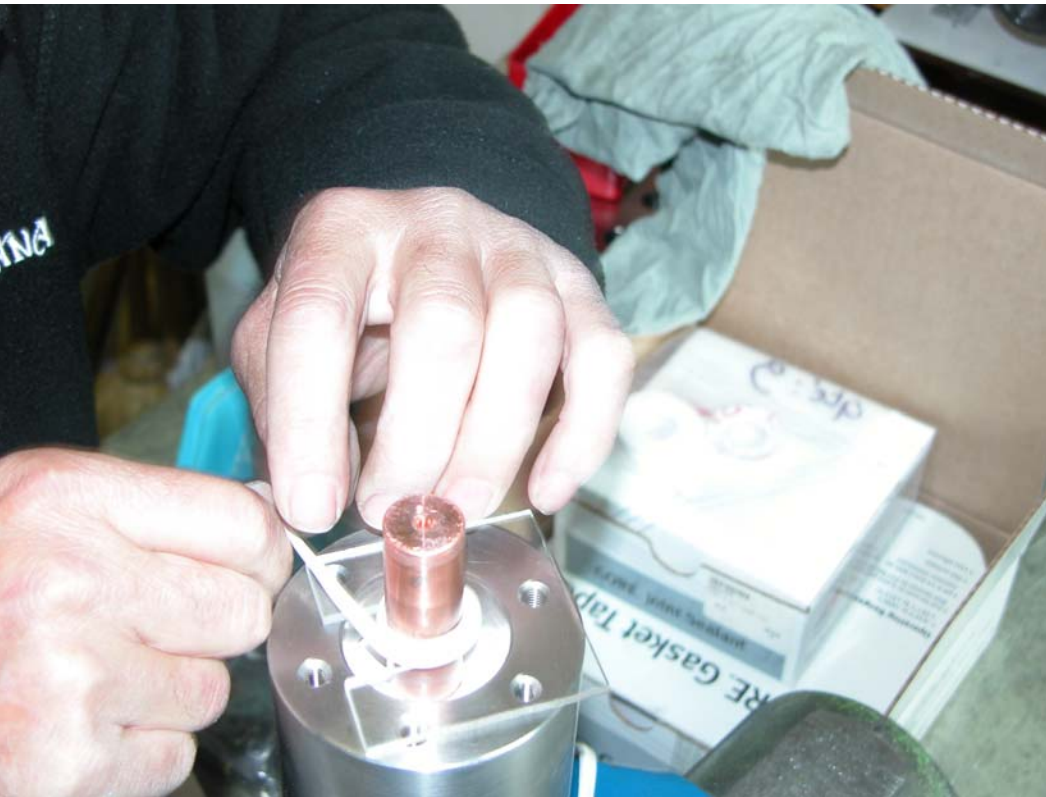
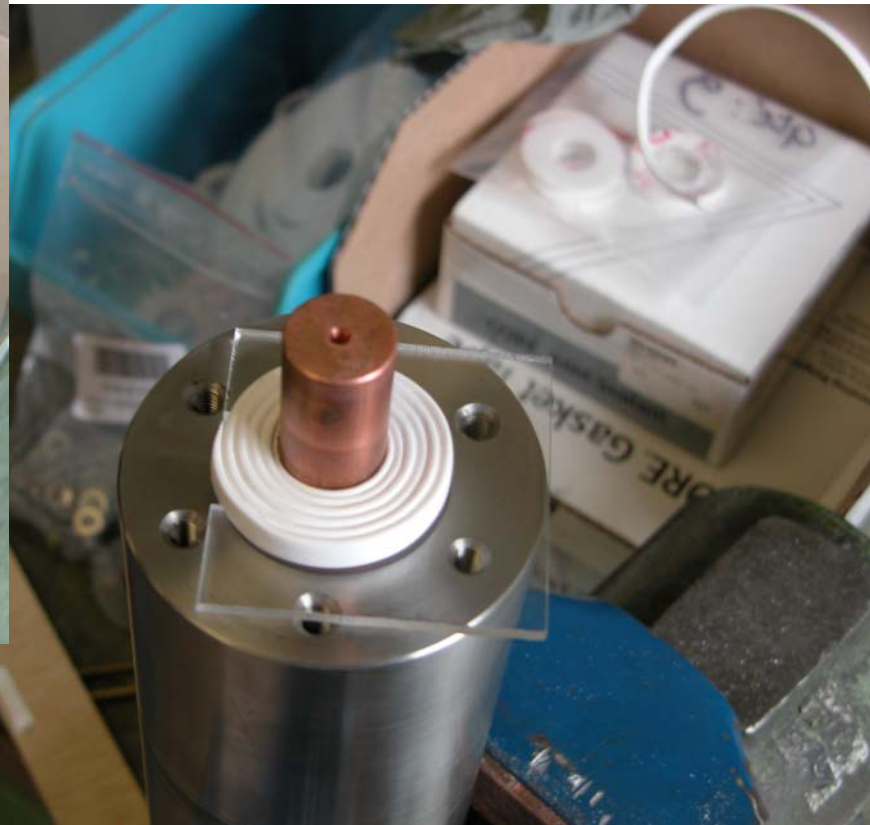
Installing the GoreTex in Test Fixture

- 2.5×10^{-5} mbar l /s Ambient Background
- No observed leak at 10bar Room Temp
- Initial cooldown, flush: substantial He leak
- Further tighten by closing gap 1.3mm
- 1.3×10^{-3} mbar l /s leak rate
- Shock cooled in LN₂ bath
- 3rd cycle cooldown
- 0.8×10^{-3} mbar l /s leak rate → 12 mg/day

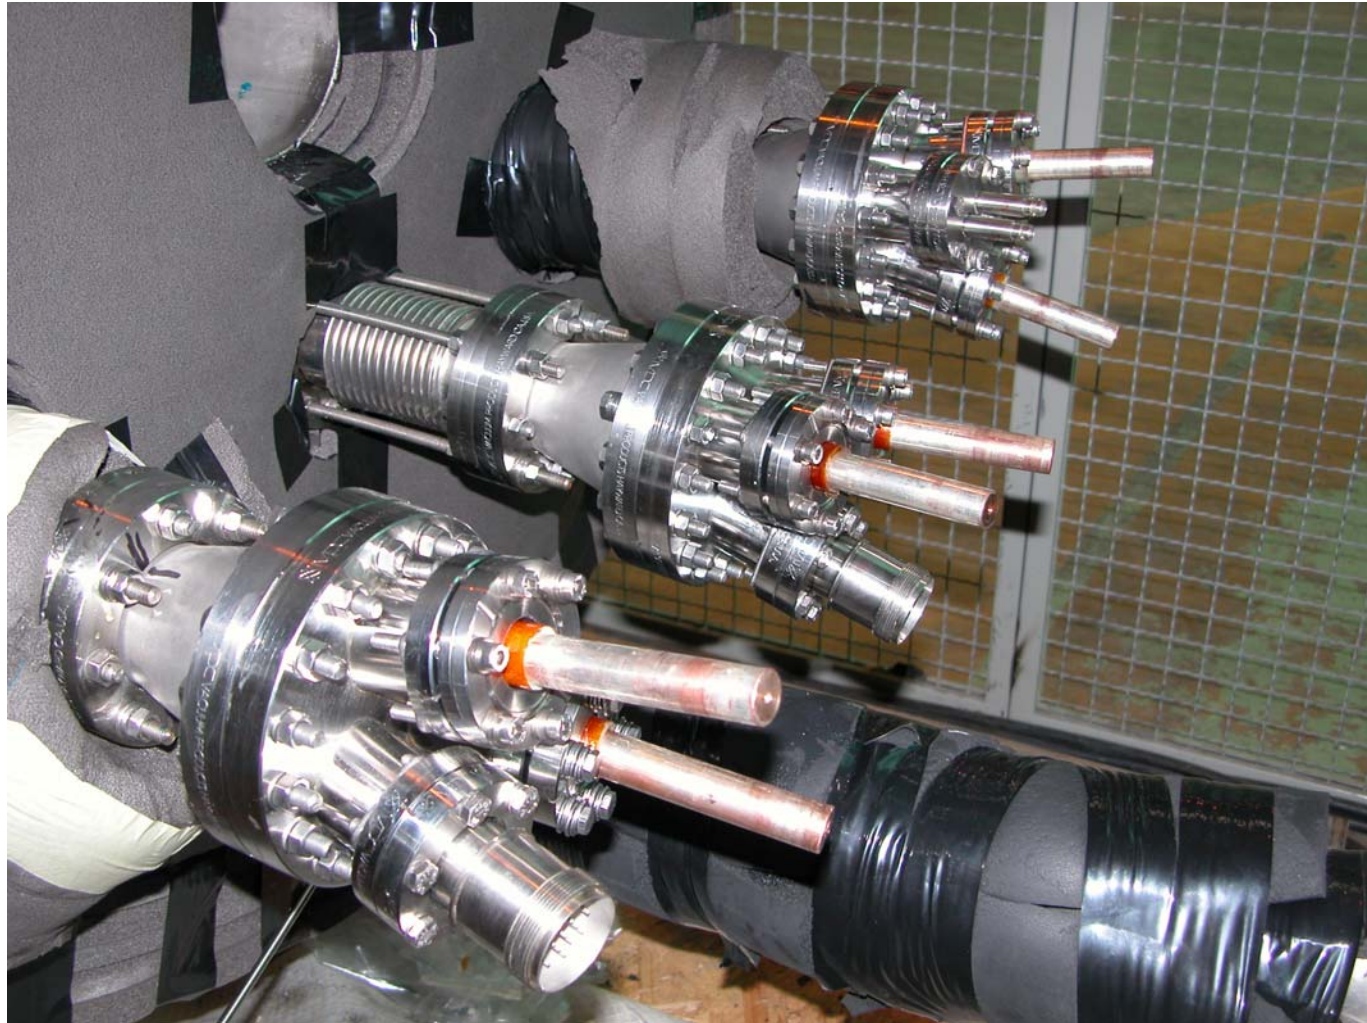
The Reassembled Leads

- Coil 3 outer set to 13 N-m
- Coil 1 inner set to 12 N-m
- All other leads set to 10 N-m
- No observed leaks in all leads with magnet filled to 80% level with LN₂ and 5bar N₂ gas

- A full warmup to room temperature and 2 day cooldown took place June 8-10.
- No observed leaks in all leads with magnet filled to 80% level with LN₂ and 5bar N₂ gas.

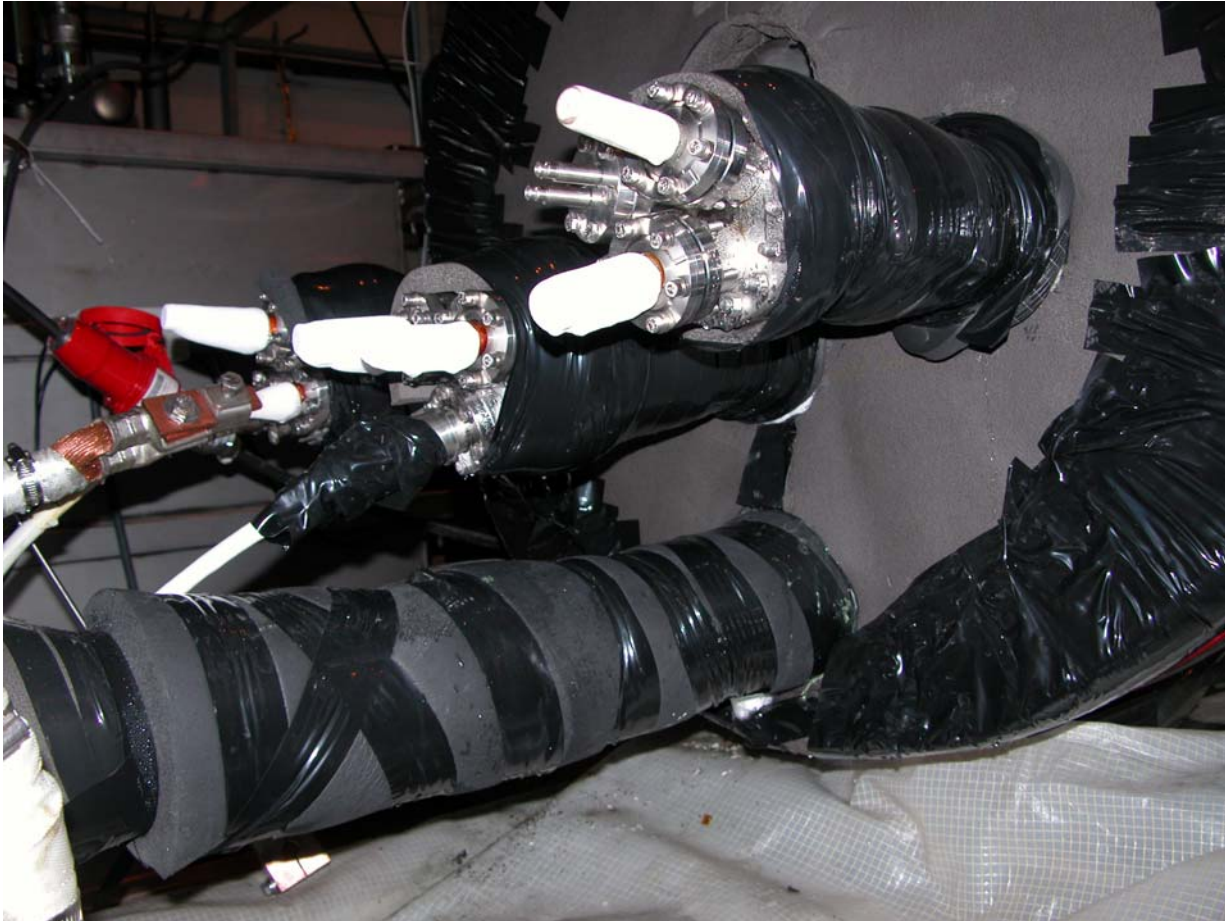
Frost Buildup Reduced

Magnet
temperatures
from 83° to
 130° K
