T2K Target Remote Handling

CJ Densham, MD Fitton, M Baldwin, M Woodward Rutherford Appleton Laboratory In collaboration with KEK: T Nakadaira, S Tada, A Ichikawa, T Sekiguchi, Y Yamada

and TRIUMF: C Mark, C Fisher

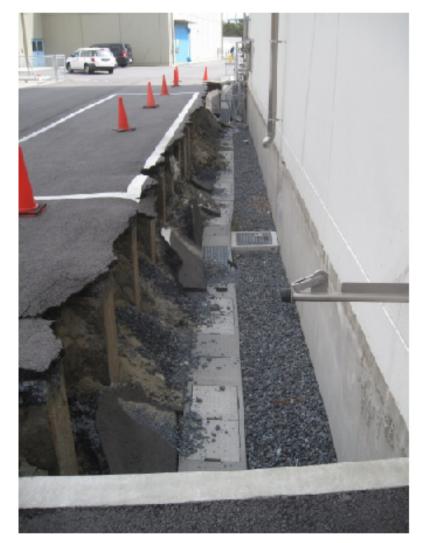
Damaged!! (;°Д°)! Not dealt yet Σ(;°Д°)!! •Facilities Around the building

: caved in!

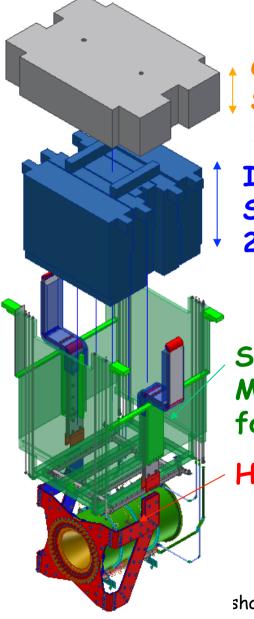
Remote Maintenance of Horns

Horns are shielded by iron and concrete Concretshields and workers only have access above Shield these shields.

1m Iron Shield 2.3m

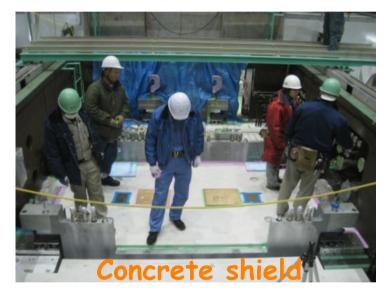
Support Module for Horn

Horn

Horns and shields are handled by remote controlled crane.

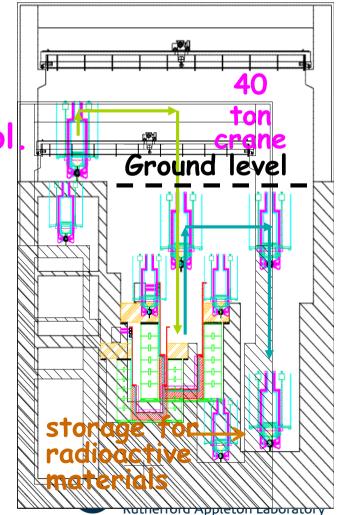
Remote maintenance of horns

Radioactive(>1Sv/h) horn is moved below ground-level and kept in the storage for radioactive materials for several years.

- •New horn is installed.
- All work done remotely with 40 ton crane & remote sling tool

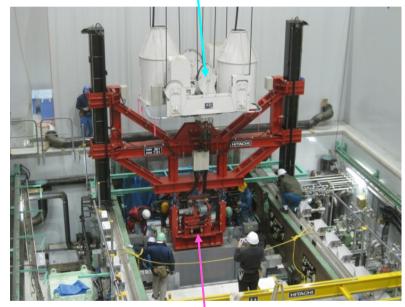
Remote Controlled Crane for TS

A numerical controlled crane is used in the TS. A remote handling machine is attached to this crane.

Crane

We need a few mm in x, y, z direction and 0.5 degree in rotation for the position accuracy when horn exchange. To secure such accuracies, we use this numerical controlled crane in a few cm region and the mechanical guide in a few mm region.

This crane has a spare system.

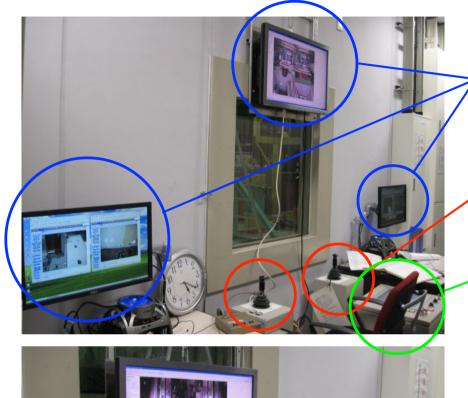
Crane control room

, Display for the camera

Control stick (for the manual operation mode)

Control panel

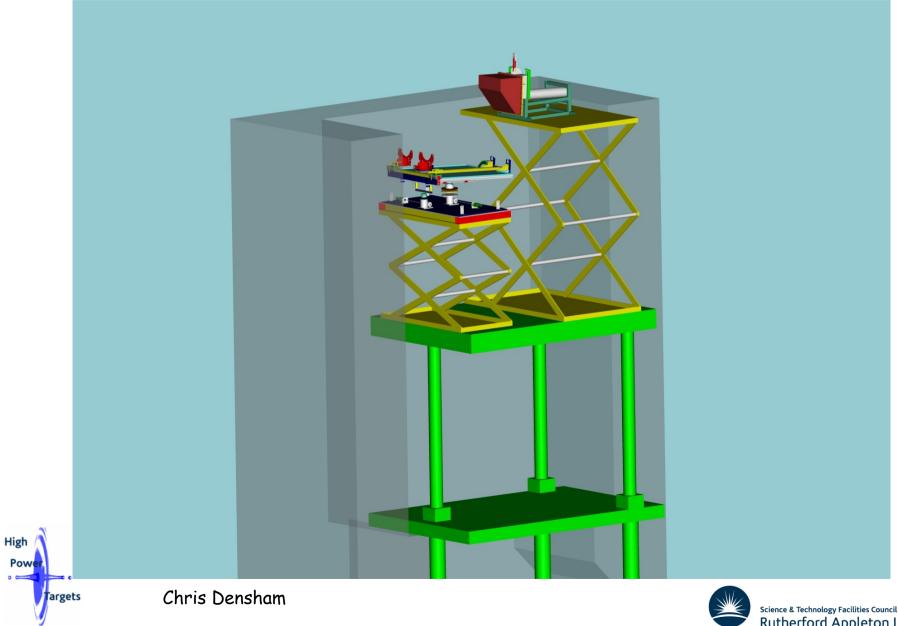
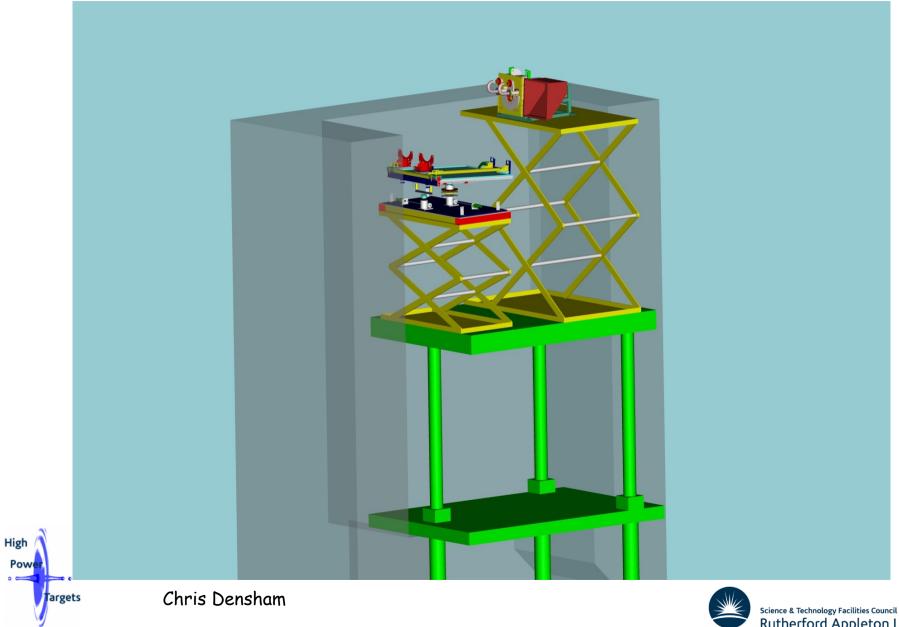
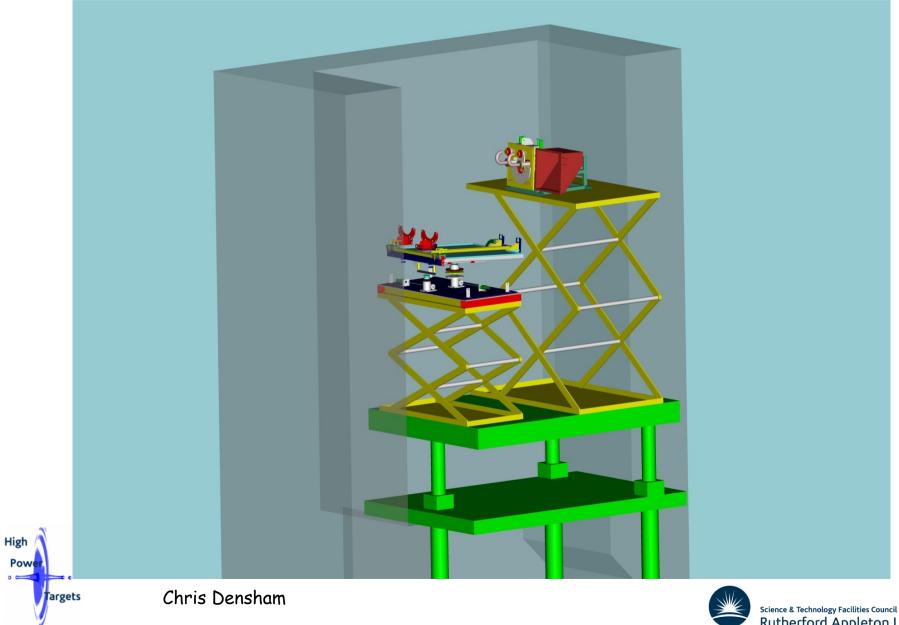
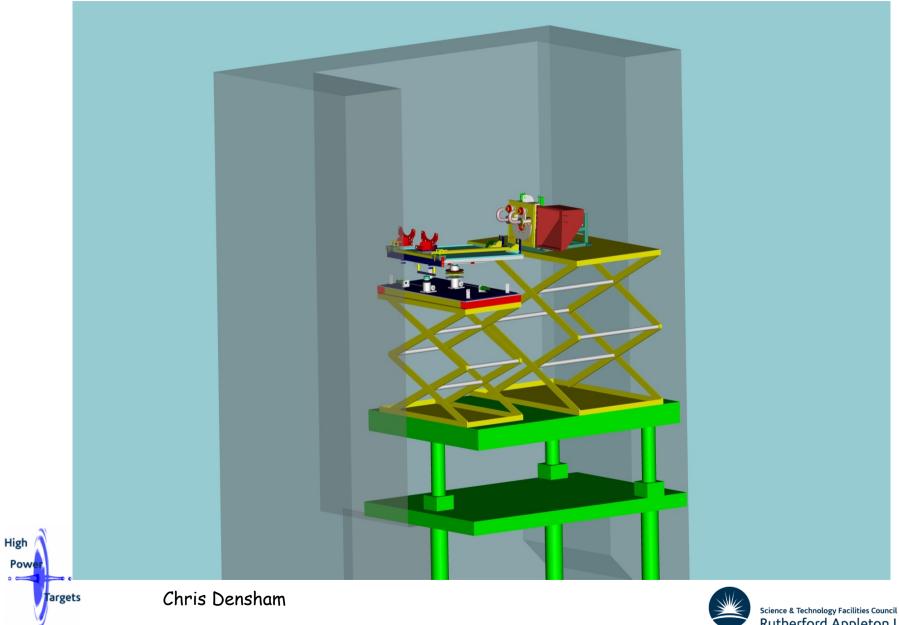
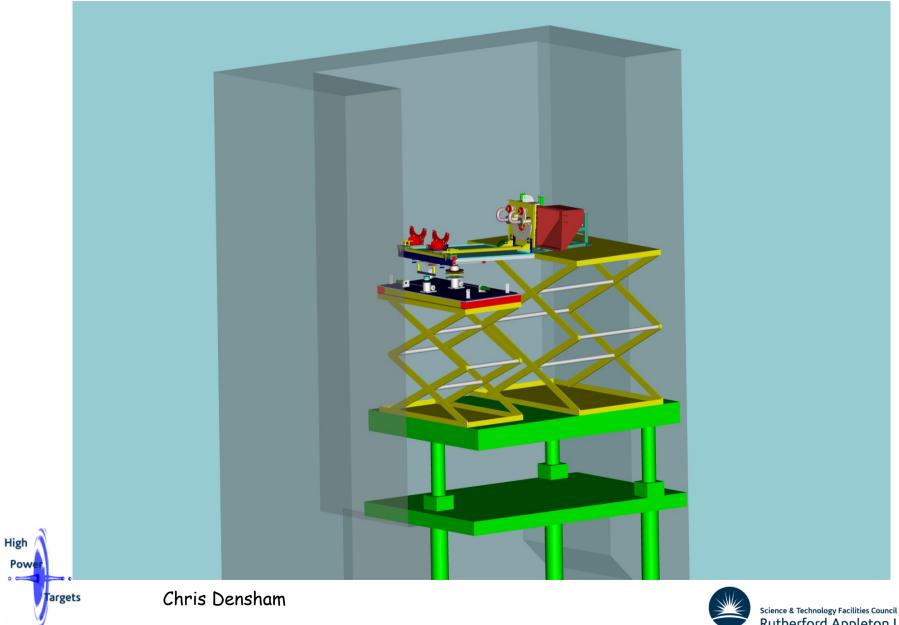
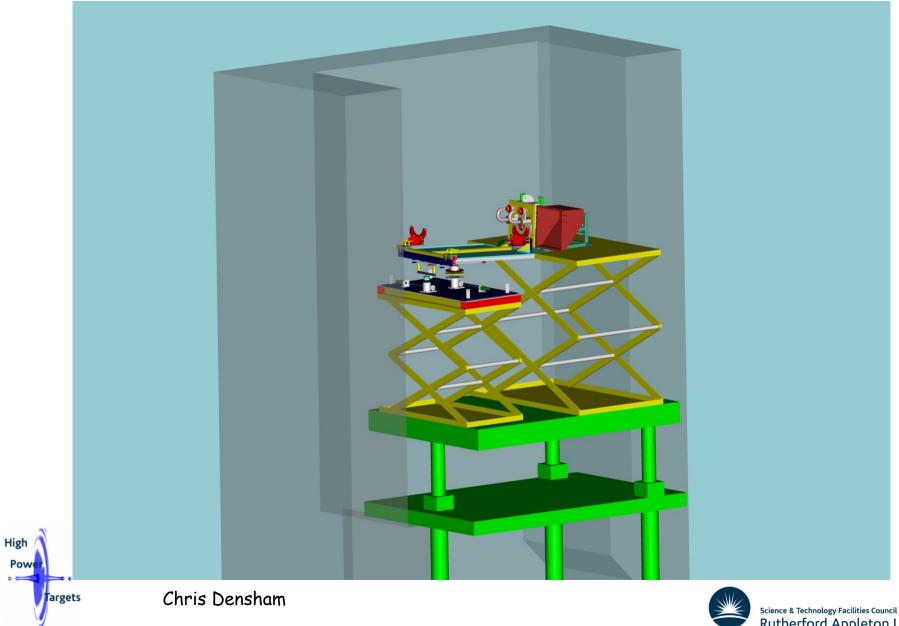
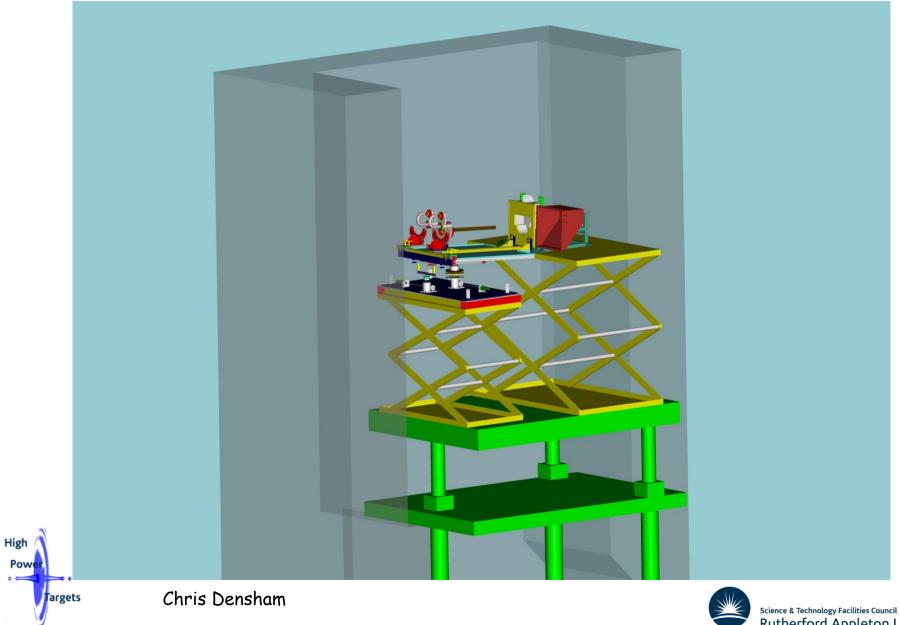
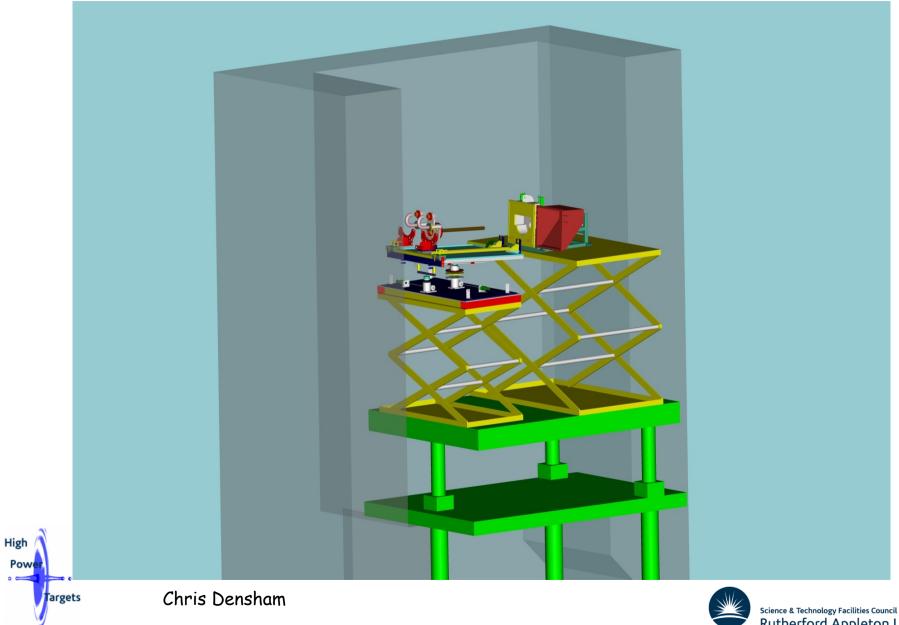
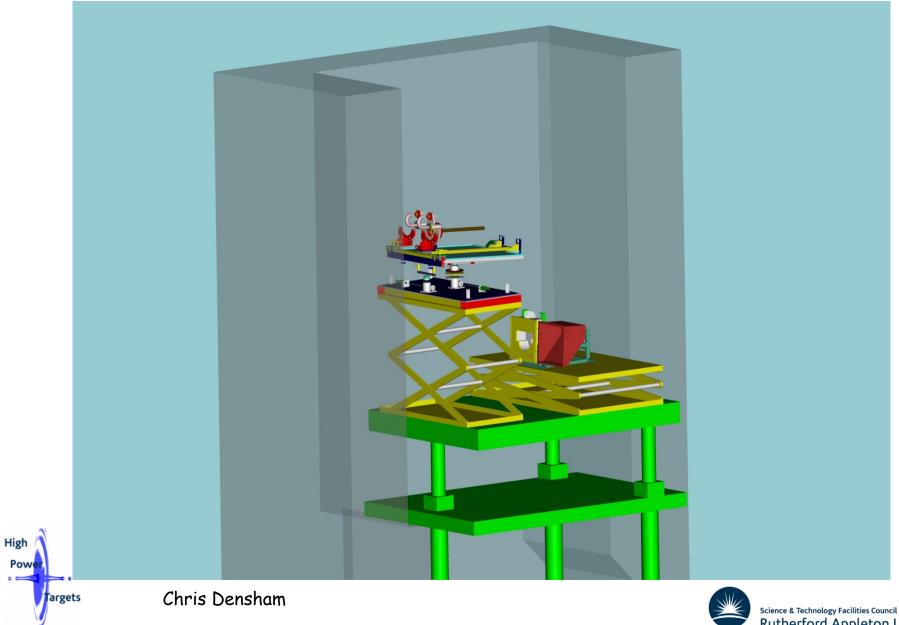
- Want to be able to replace a failed target and re-use Horn 1.
 - 1 month cool down required (at 750 kW operation)
 - Horn 1 with failed target to be lifted from beamline and installed in Remote Maintenance Area
 - Failed target to be removed, new target installed, and Horn 1 assembly re-installed in beamline.
 - Failed target to be placed inside disposal flask
- Many limitations within Remote Maintenance Area
 - Very limited space
 - No crane access lift tables only
 - Horn can only be installed in RMA with reproducibility of ±10 mm but target needs to be installed within horn to accuracy of ≈0.1 mm.

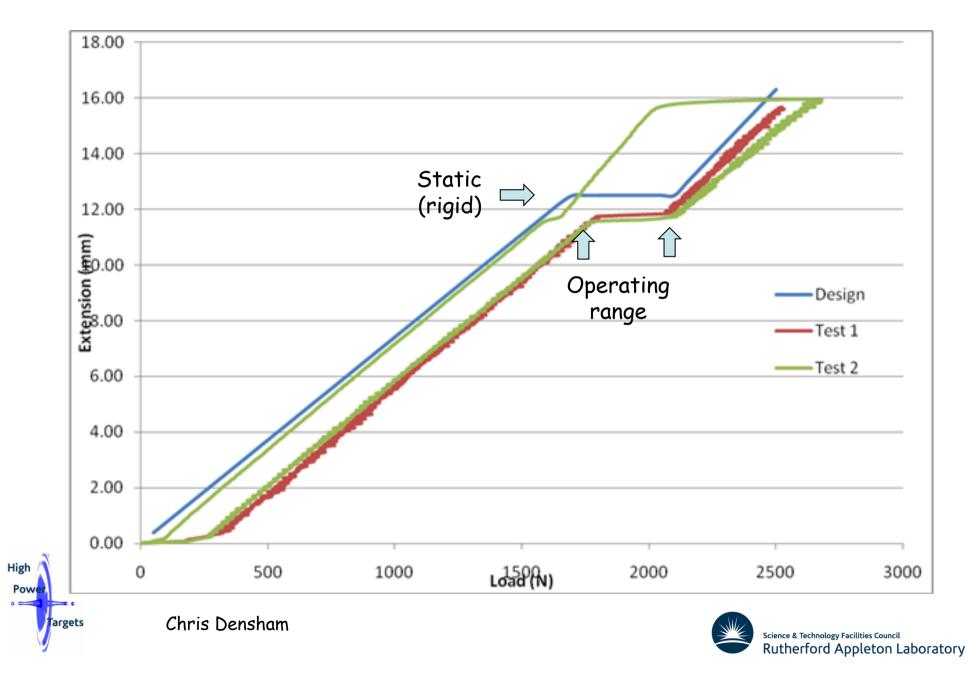
Operation of spring protection system

Load cell readouts from jacks crucial for docking exchanger to horn - more important than visual

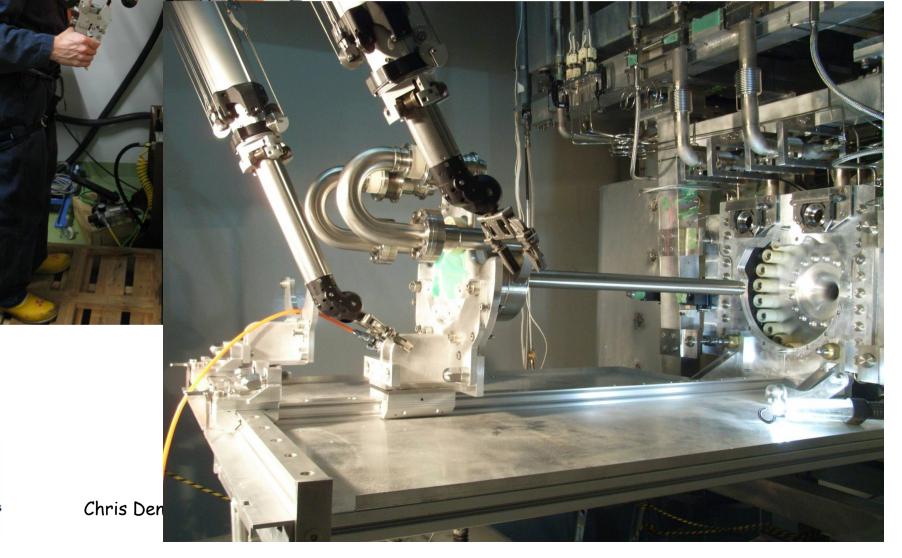
Changing a target

Science & Technology Facilities Council **Rutherford Appleton Laboratory** Chad Fisher – master manipulator operator at work
