Optical Diagnostics

T. Tsang (BNL)
(Feb. 2, 2008)

Princeton, ORNL, MIT, CERN, and BNL

Design and construct a high-speed optical camera system, perform image collection and data analysis

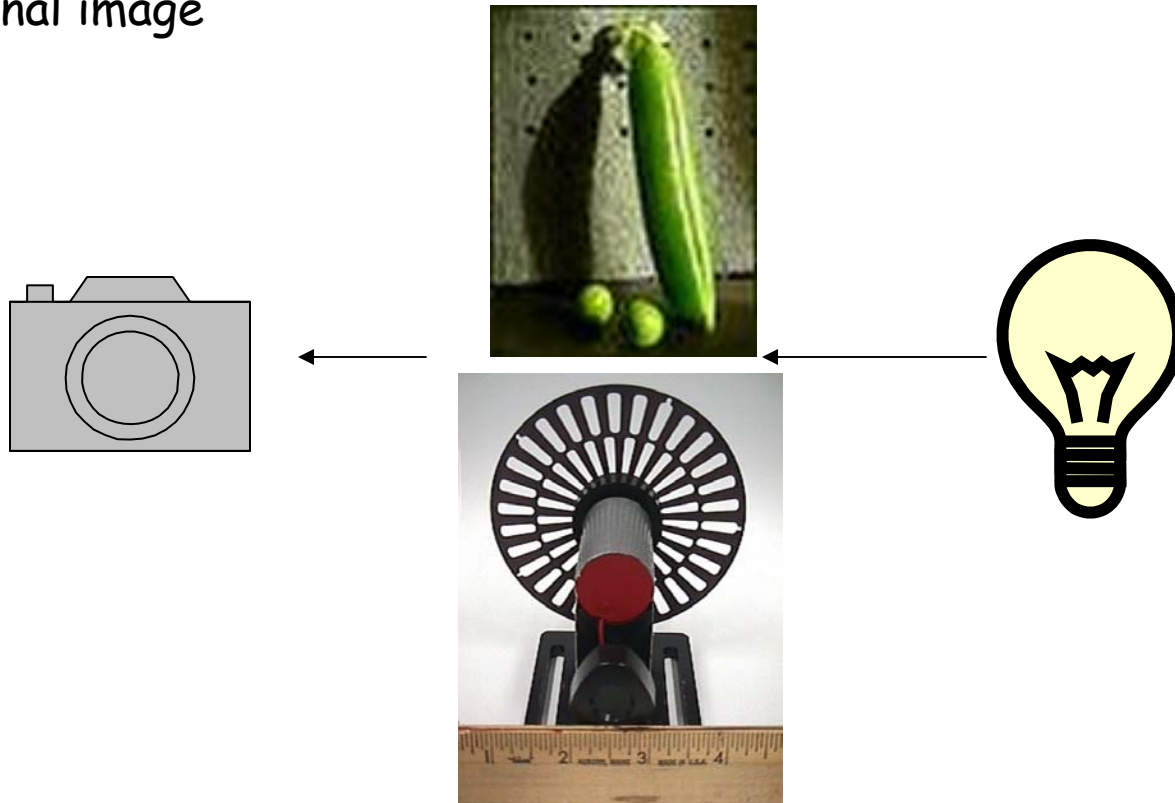
high-speed camera to fast record transient phenomena

- back illuminated laser shadow photography technique
- freeze the image of events using high speed camera (up to $1 \mu\text{s}/\text{frame}$)
- synchronized arrival of short laser light pulses illuminate onto the target
- the motion of the target after proton impact is freezed by high intensity short (150 ns) laser pulses
- 2-dimensional image

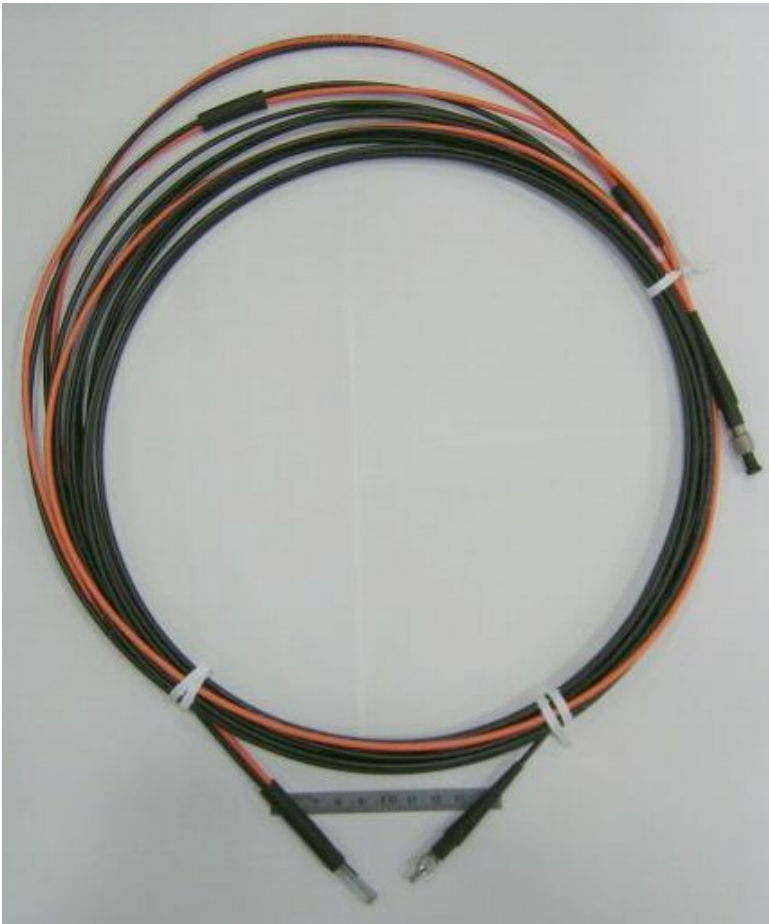
All-in-one – 10 meter long imaging and illuminating fibers

sapphire ball lens

Grin objective lens

imaging fiber, $D=1$ mm

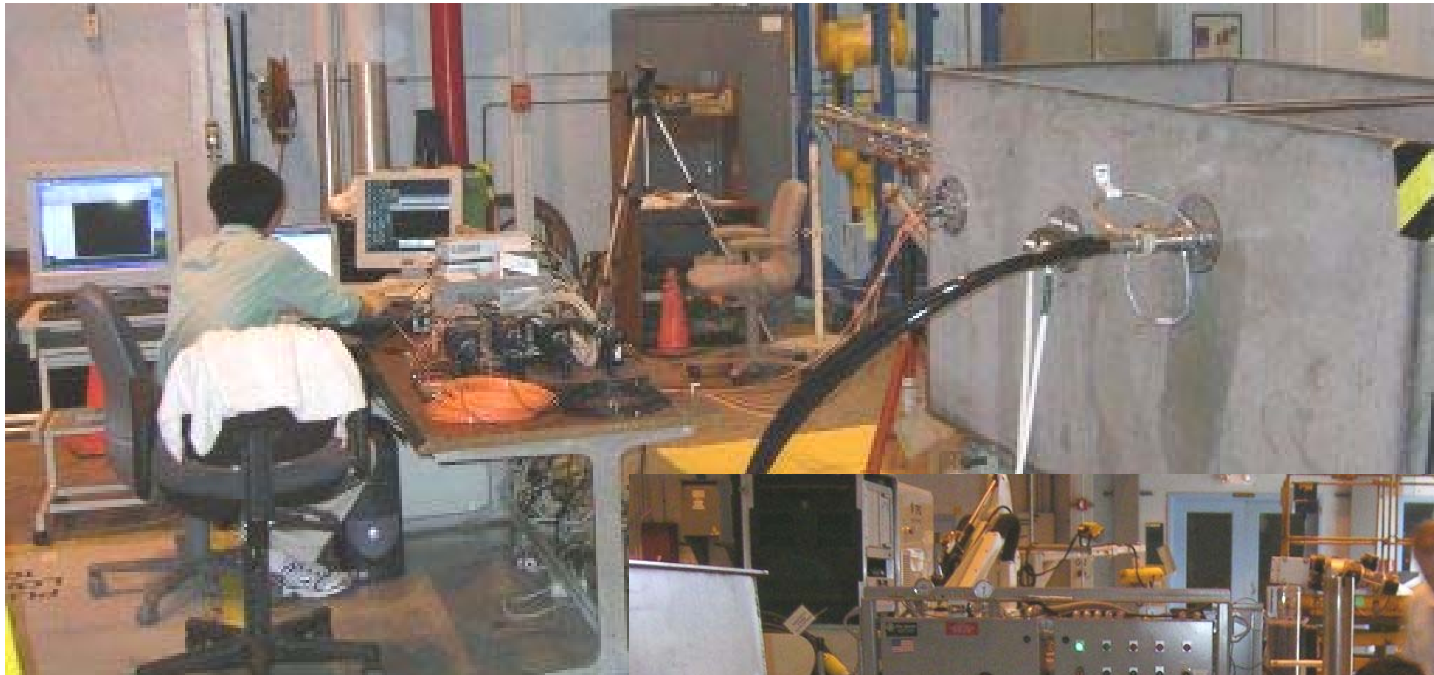
nozzles A, B, & C

Nozzle Configuration

- A** : Reduction after 180 degree bend with 44 mrad angle with respect to magnet axis.
- B** : Reduction before 180 degree bend with 44 mrad angle with respect to magnet axis.
- C** : Reduction after 180 degree bend, but straight nozzle with no tilted angle with respect to magnet axis.
- D** : Nozzle A is reamed through the nozzle flange.

Nozzle C shows stable shape and uniform velocity.

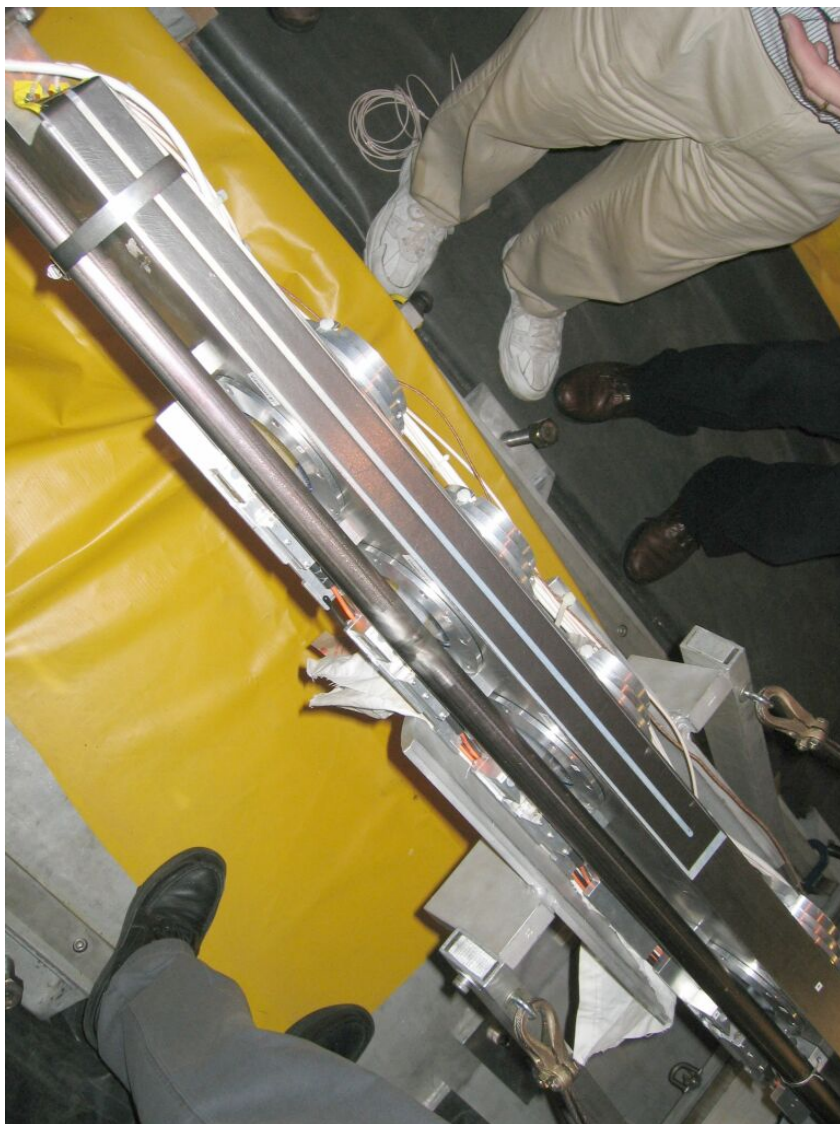
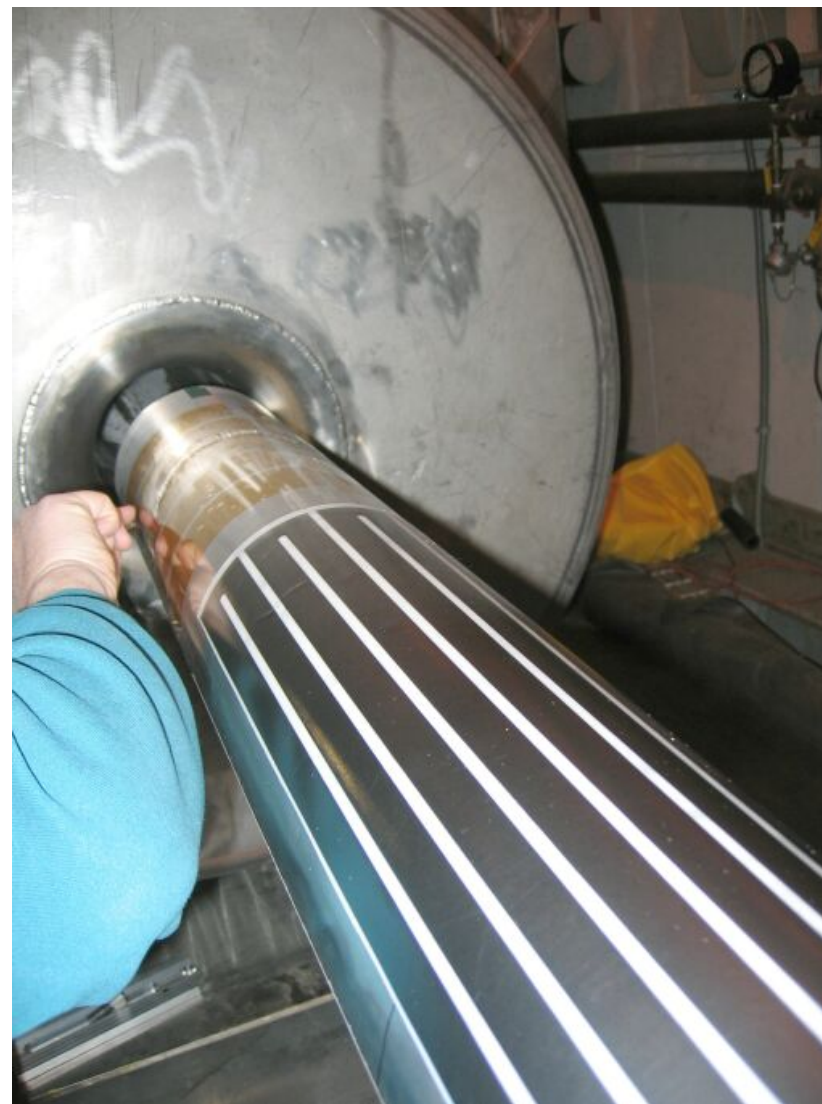
heaters installed on the primary and on the snout

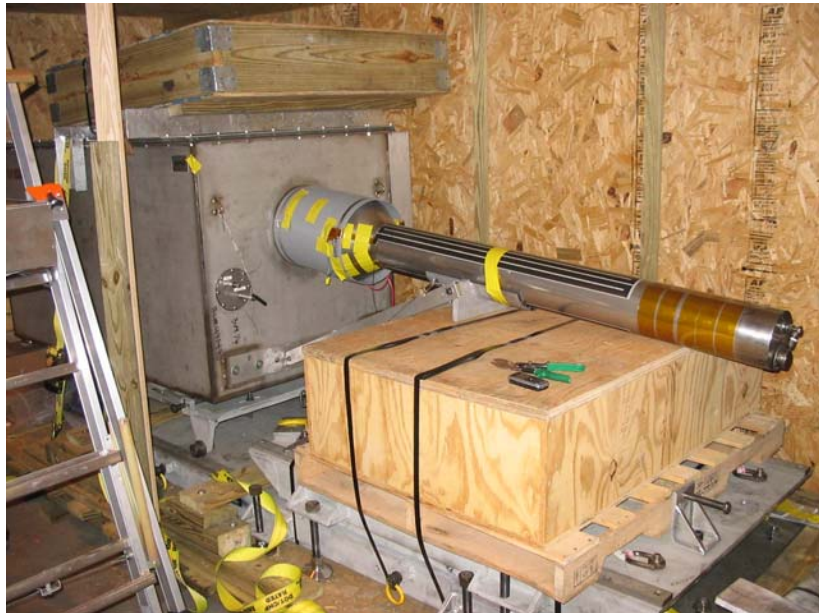
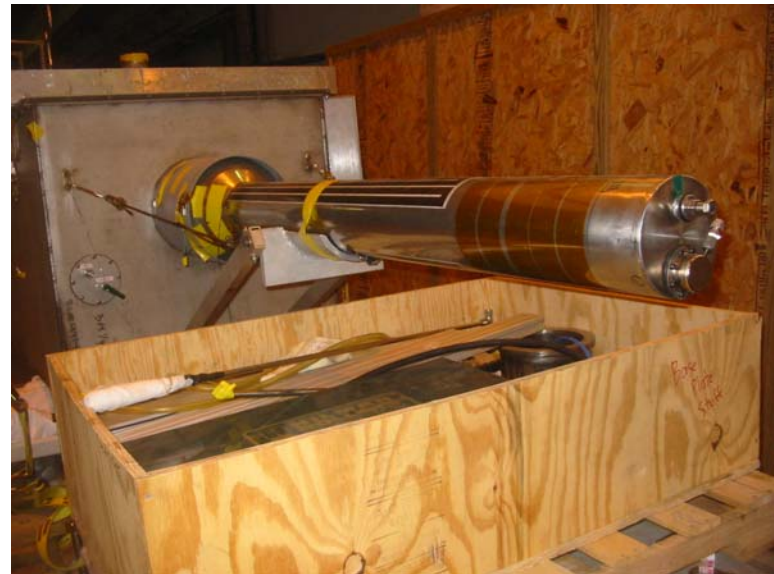
Snout Fell 10 cm
Rubber Collar Stretched by ~ 5 cm.
¿Damage to the Primary Containment?

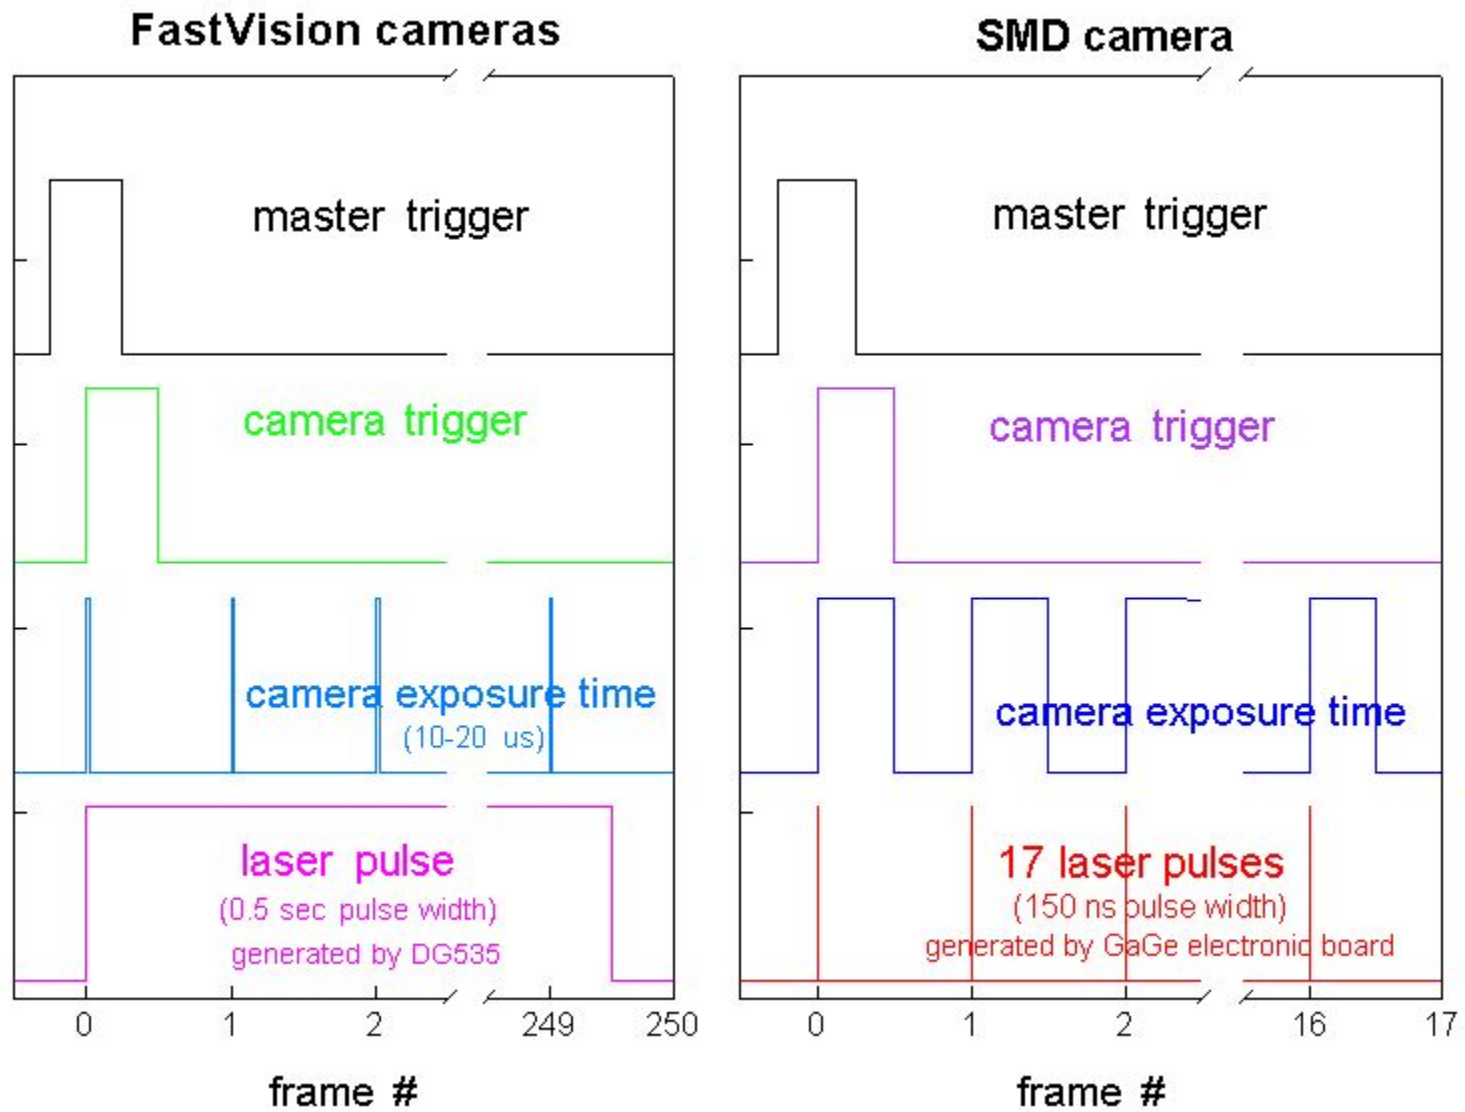
Trigger pulse sequence for FastVision & SMD Cameras

typical 2 ms/frame
total of 256 frames

typical 0.1 ms/frame
total of 16 frames

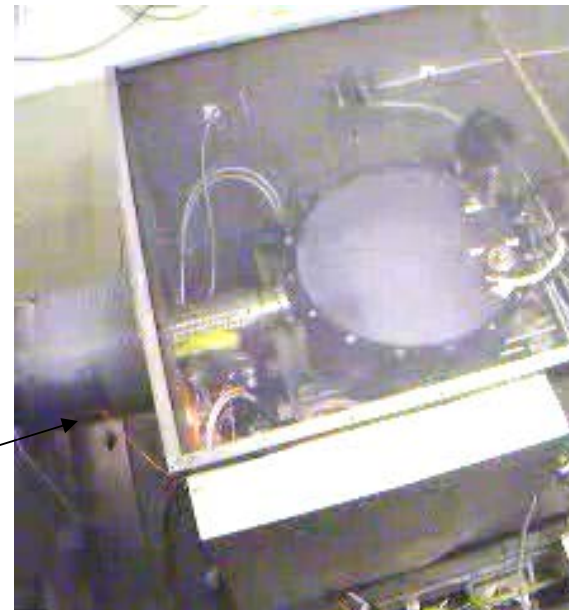
puncture made for passage of
replacement optics head

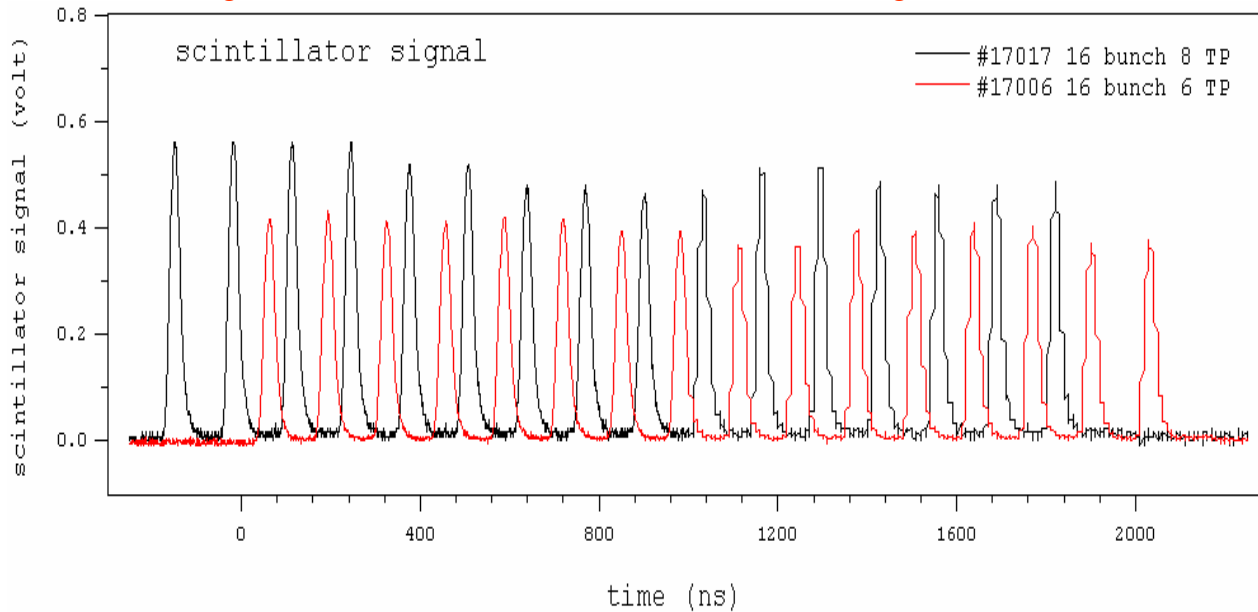
Optical scintillator detection signal - Channel 0

Scintillator signal indicated that : 1st 8 bunch has better timing resolution than the 2nd 8 bunch
