Hg System Operation Review

Muon Collaboration Friday Meeting

April 13, 2007

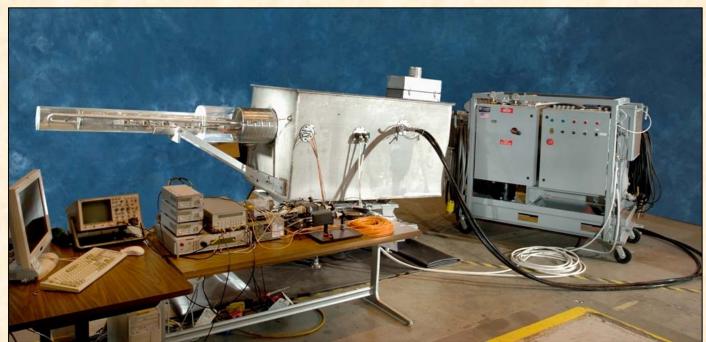
Hg System Equipment

- Syringe pump
- Hydraulic power unit w/control system
- Optical diagnostic system
- Baseplate support structures

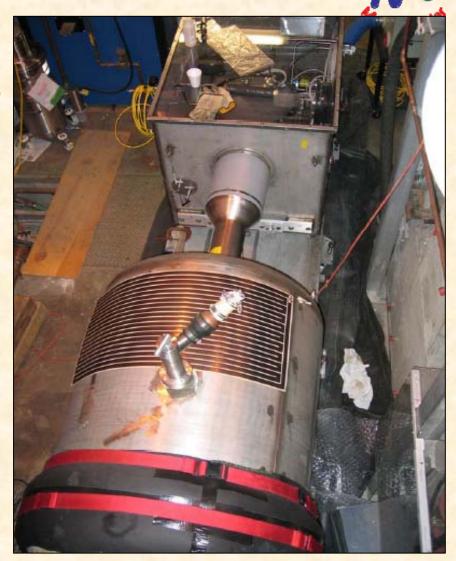
- Completed 14 runs with field (10-15-20 m/s jets, 5-10-15 Tesla fields)
- Syringe pump performed as expected, no leaks
- Expected increased Hg pressure due to field, but no effects observed
- Water vapor issues inside jet chamber resulted in addition of strip heater on exterior of chamber
- External bore heater had to be reconfigured due to clearance issues

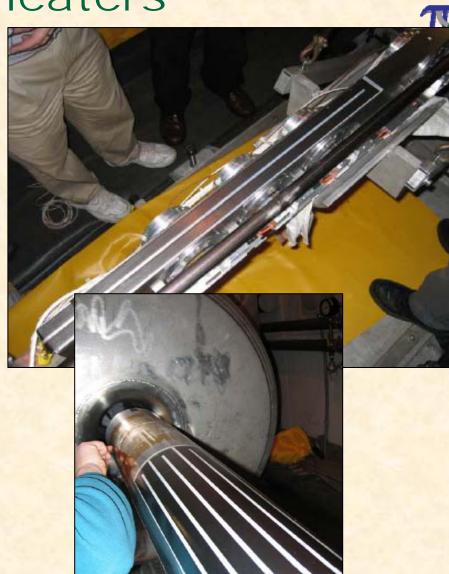
Addition of Strip Heaters

- Approx 0.5L water not removed from system prior to Hg operations at ORNL
- Insertion into magnet caused condensation on viewports
- Modified existing flexible heaters to prevent condensation
- New heaters and controllers procured for CERN operation

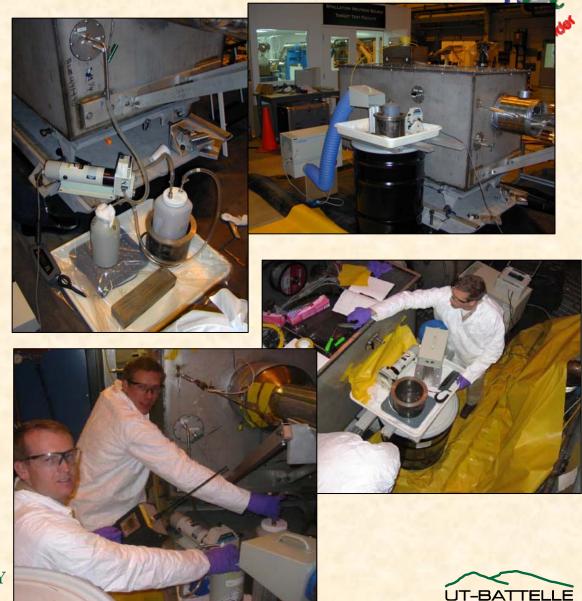
Hg Fill & Drain Procedures Tested

- Two fill and drain cycles completed
 - MIT cycles observed by CERN personnel
- Peristaltic pump method works well, minimizes spill risk & vapor generation
- Drain into intermediate container reduces chance of overfilling flask
- Flasks weighed empty & full to track inventory
- No spills or operational problems

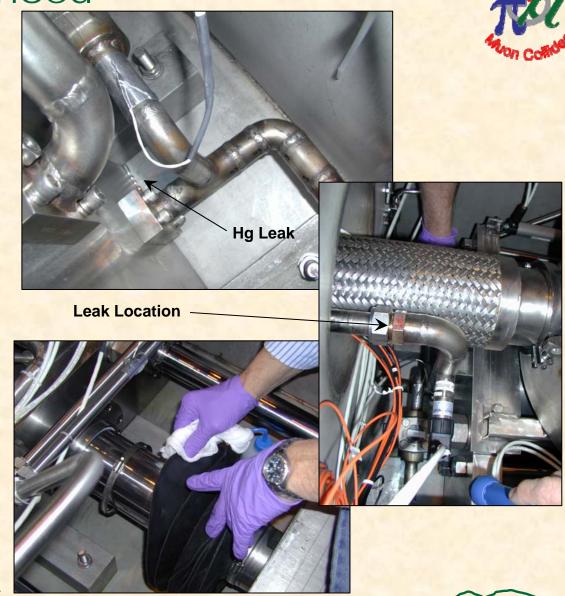
Hg Leak Experienced

- Very high vapor levels inside secondary detected at ORNL
 - No vapors detected outside secondary
 - Scavenger snorkel successfully removed vapors
- Suspected Hg cylinder bellows & made effort to seal seams
 - Upon disassembly, no vapors detected inside bellows
- Small Hg leak discovered in nozzle supply threaded joint
- Successfully removed liquid and tightened joint

Bellows
