MERIT Primary Containment Chamber Surface Inspection – Updated Dec 5, 2011

Surface Profilometer Measurements of MERIT Primary Containment Chamber

- Concern that high-velocity mercury beads generated during MERIT experiment might have induced pitting on the interior surface of mercury jet chamber
- Photography of the surfaces in Sept 2010 revealed no observable surface issues
- Desired to have a quantitative measurement of the surface profile around the viewports

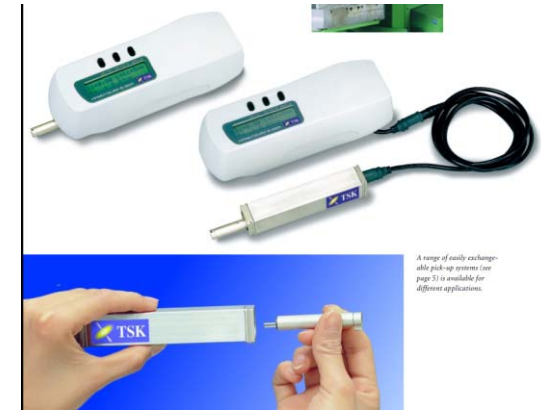
Zeiss HandySurf E-35

- Portable, hand-held surface tester for measuring roughness and contour
- Output
 - Read-out unit provides calculated values
 - Printer
 - Data points to Excel

- Traversing length: 12.5mm
- Tracing speed: 0.6mm/s
- Evaluation length: 0.4 – 12.5mm with 0.1mm step
0.4/1.25/4/12.5mm
- Measuring range: 40/160 μ m
- Resolution: 0.02 μ m
- Stylus radius: 5 μ m
- Skid: Sapphire, radius 40mm

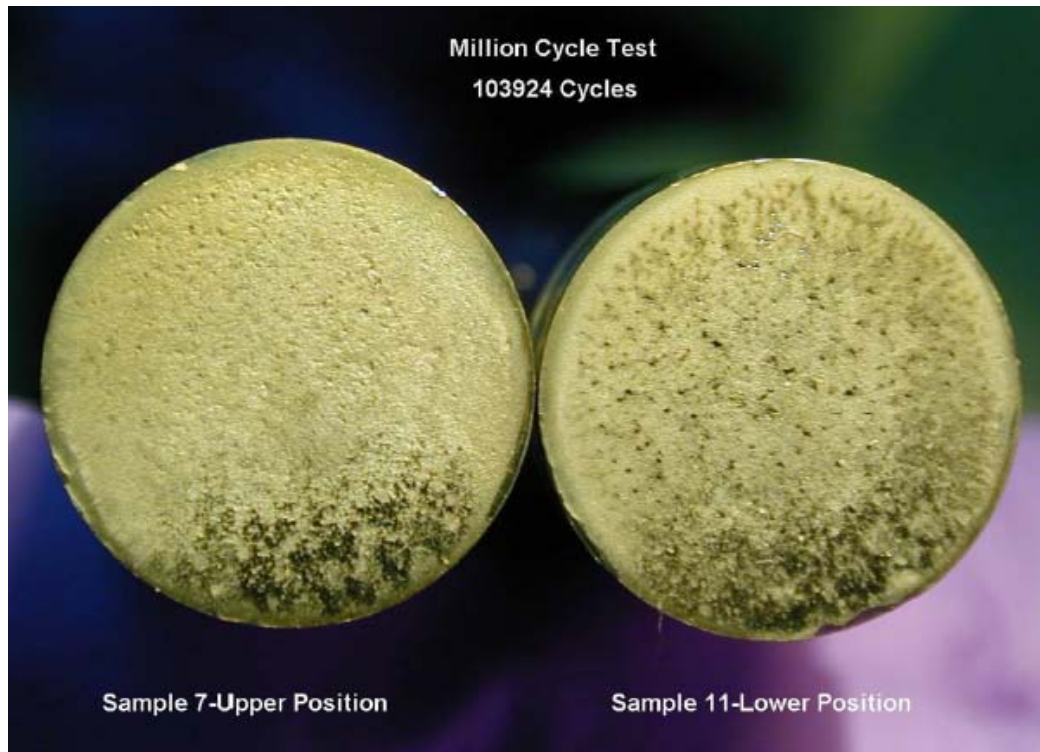
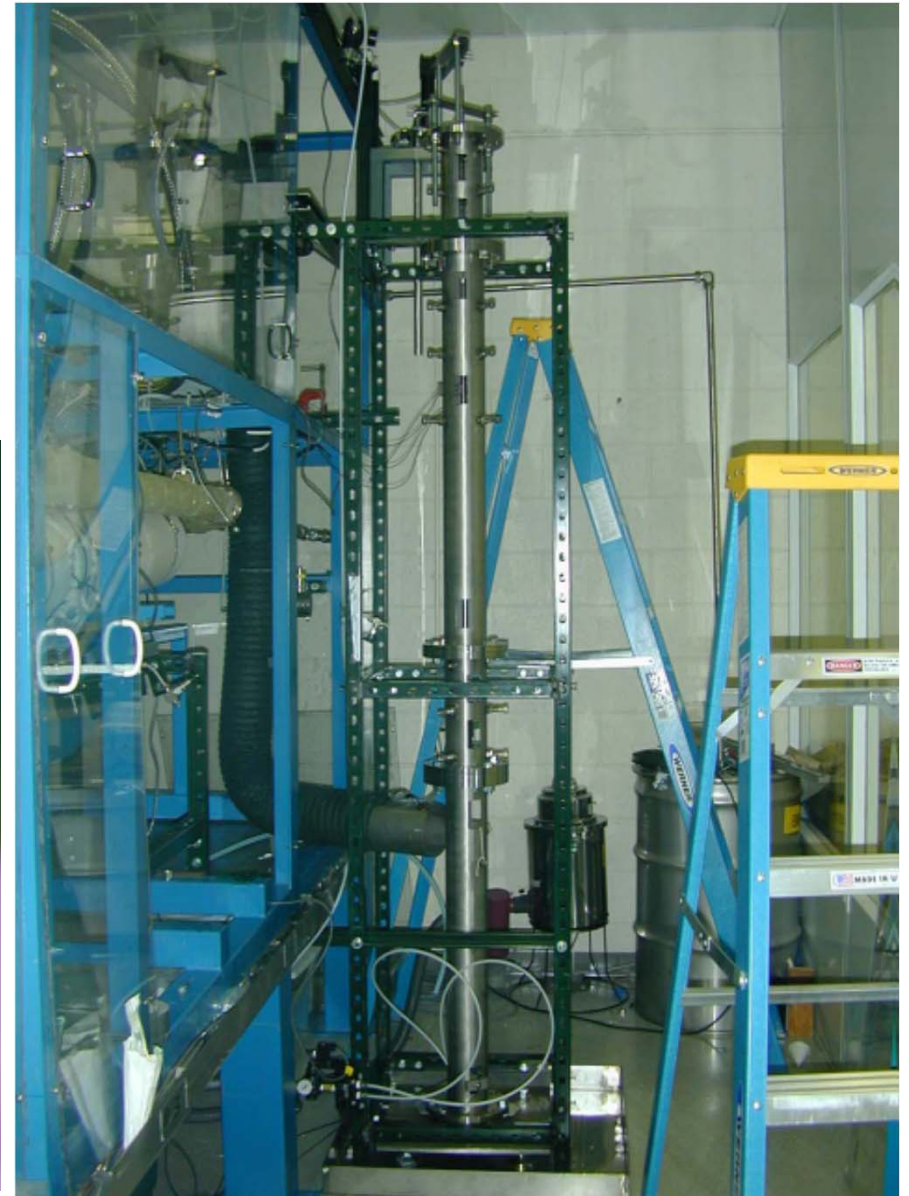
Split-Hopkinson Pressure Bar used for SNS Hg Target Pitting Simulation Studies

- Process automated for high test cycles
- 1 Hz repetition rate

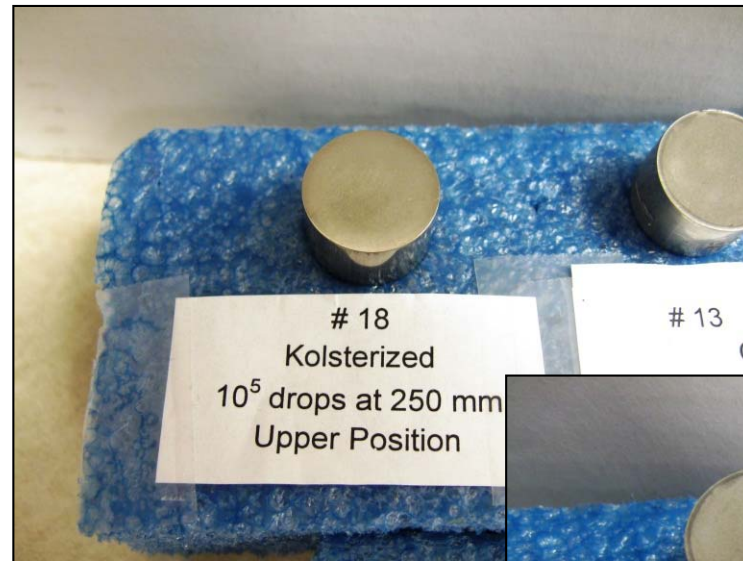
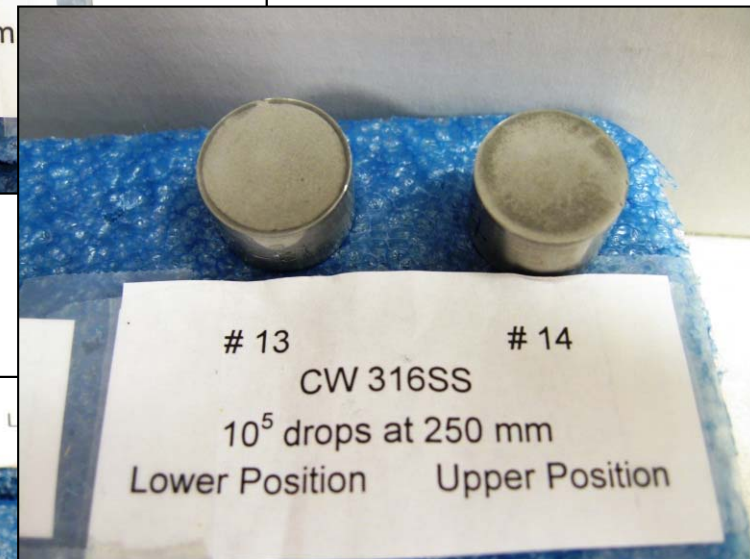
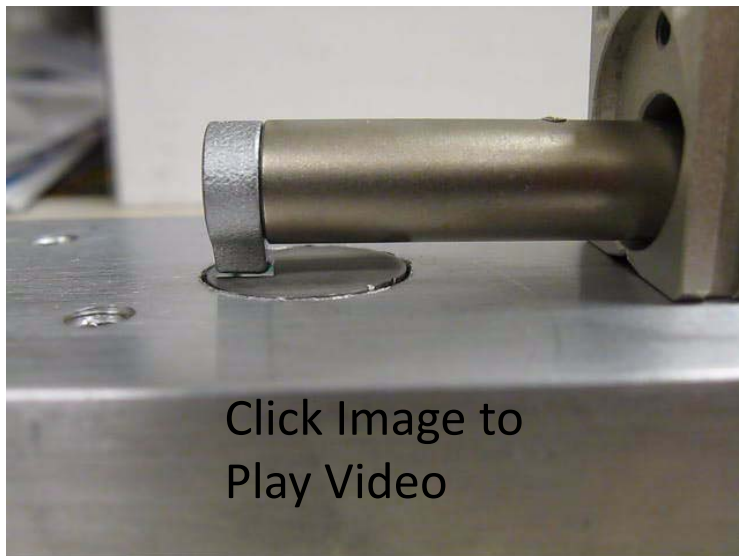
Some Control Measurements

- Specimens had known surface finishes prior to experiment
- Specimens have varying degrees of surface damage

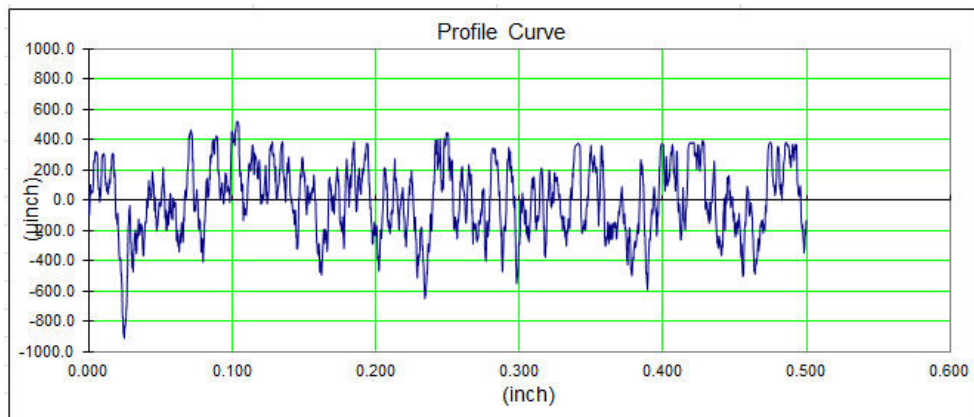
Raw Stock

- Raw stock and sandblasted specimens measured with Handysurf

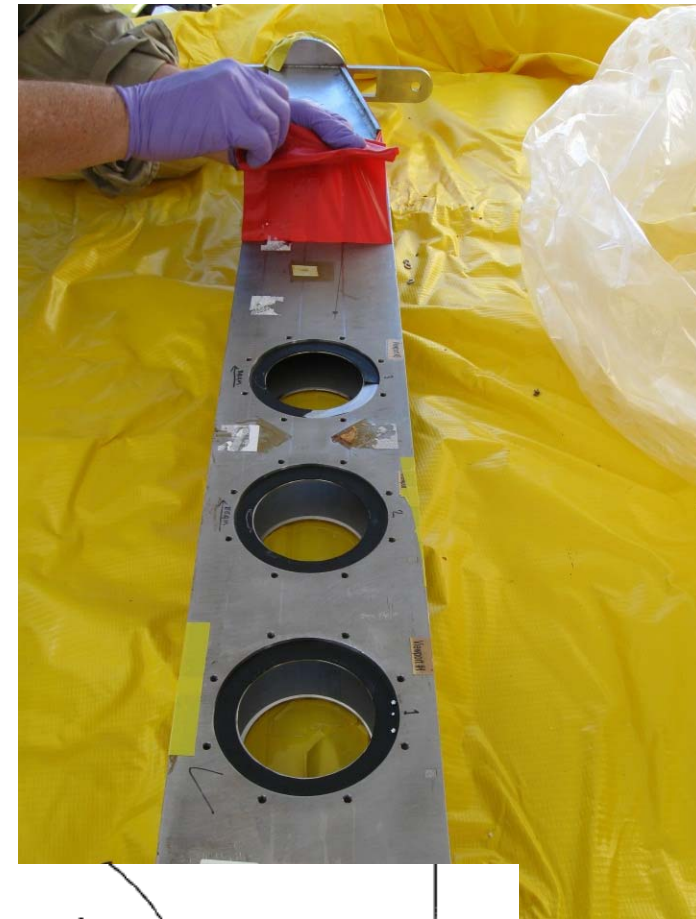
Scans Performed On/In MERIT Chamber

- Scans obtained around 4 viewports on right side as seen by beam
 - A few scans on exterior for comparison
- All scans 12.5mm in length (maximum)

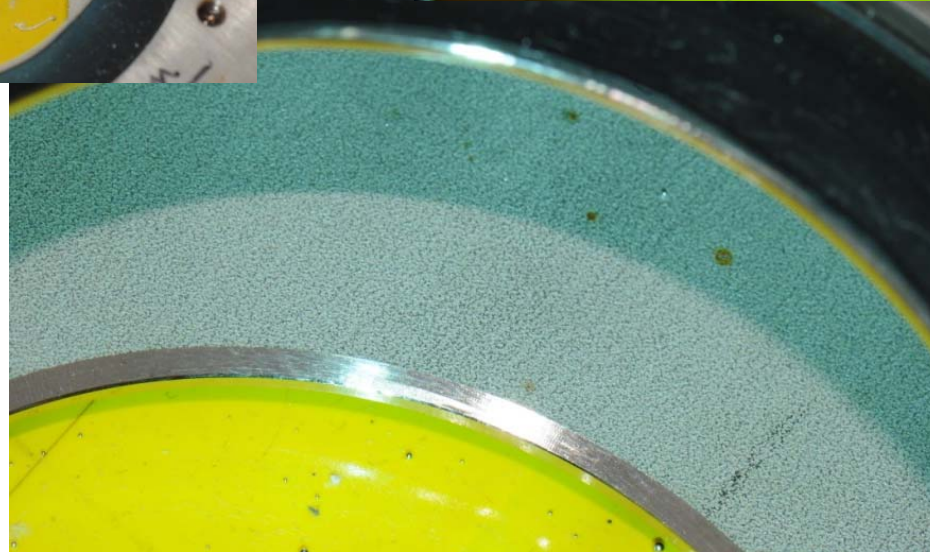
Viewport 2 Upstream Side Photos Taken Sept 2010

- General surface appearance is uniform
