# MERIT 15-T Pulsed Solenoid Magnet

**K.T. McDonald**  
*Princeton U.*  
*MERIT Safety Review*  
**CERN, 30 March 2007**

# Magnet Parameters

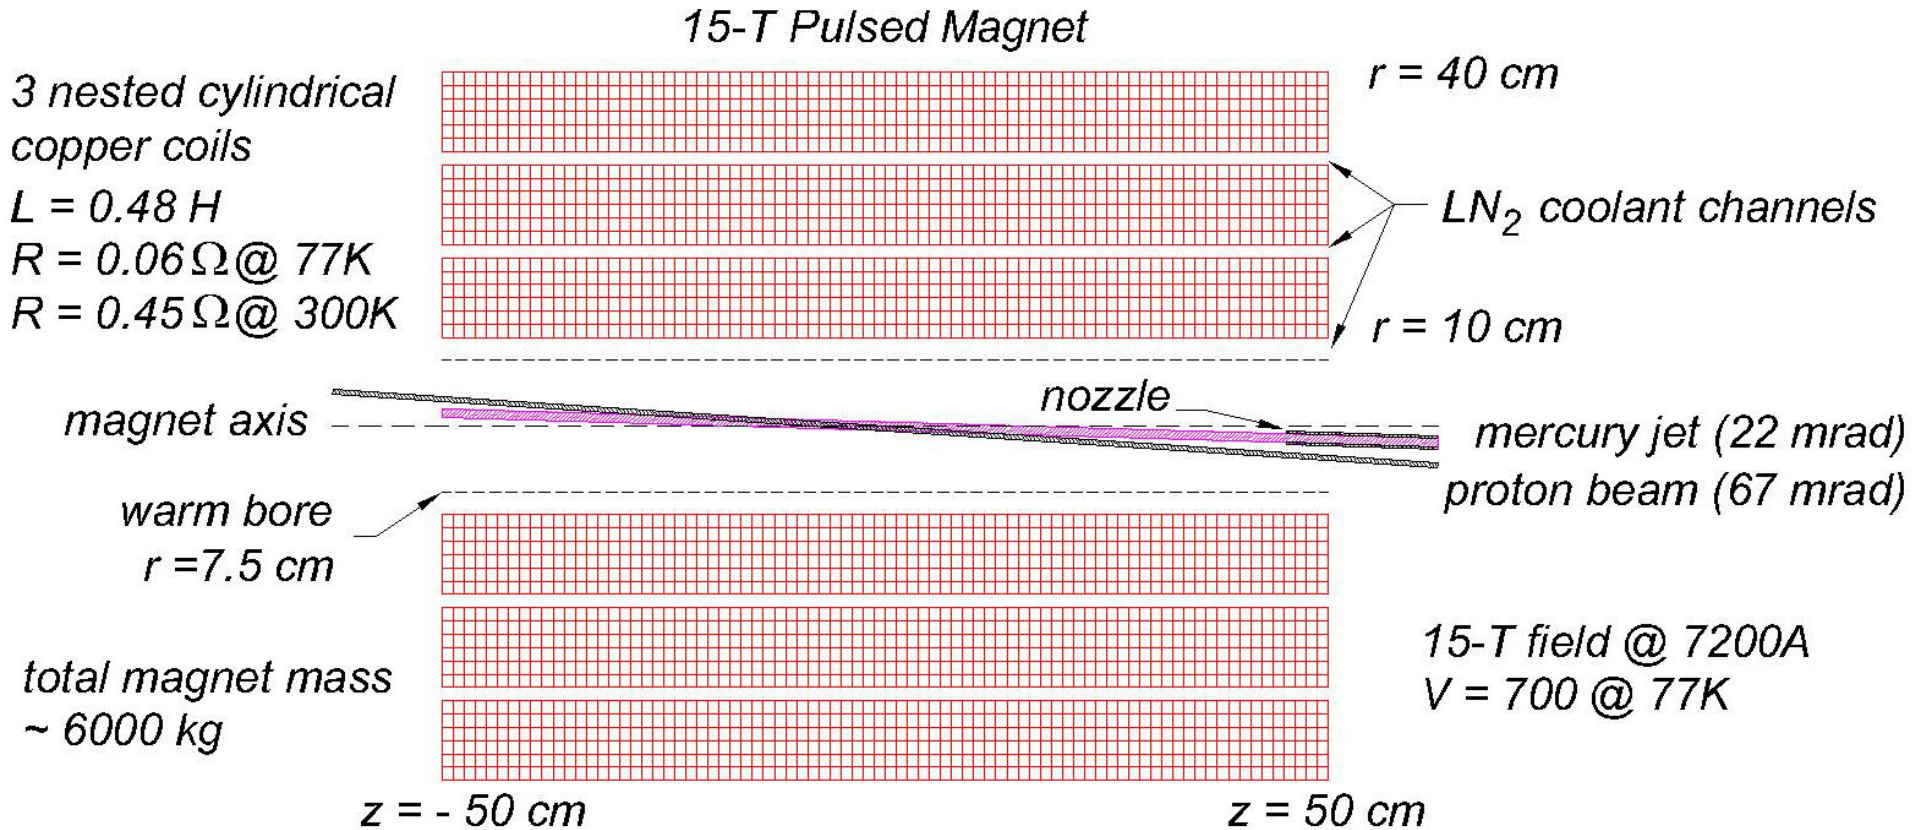
To produce 15-T field, need  $I = 7200 \text{ A}$ .

When pre-cooled to 77k by  $\text{LN}_2$ , peak voltage is 700 V, peak power is 5 MW.

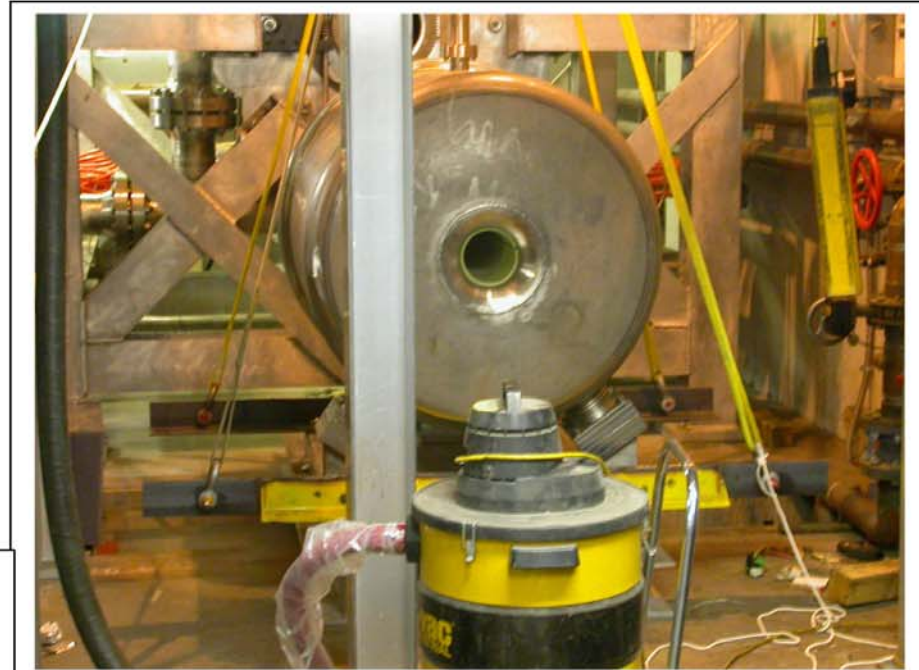
The initial lifting rig was unstable. This can be seen in the diagram below. The triangular sling arrangement is planned for use. In order for the headroom to be acceptable, the spreaders supplied by CVIP had to be extended by about 7 inches. .

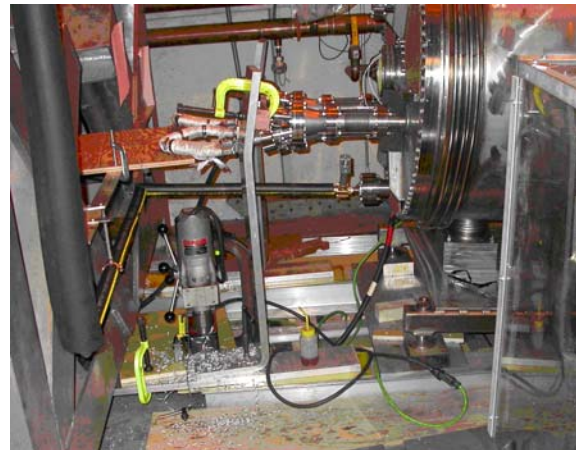
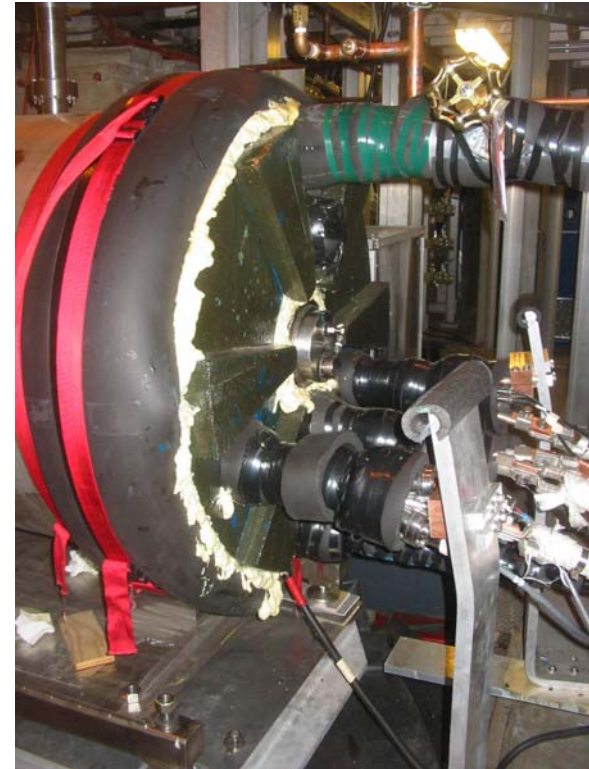
Magnet leads connected to Al bus bars at MIT.

Magnet leads will be connected to copper cables at CERN.

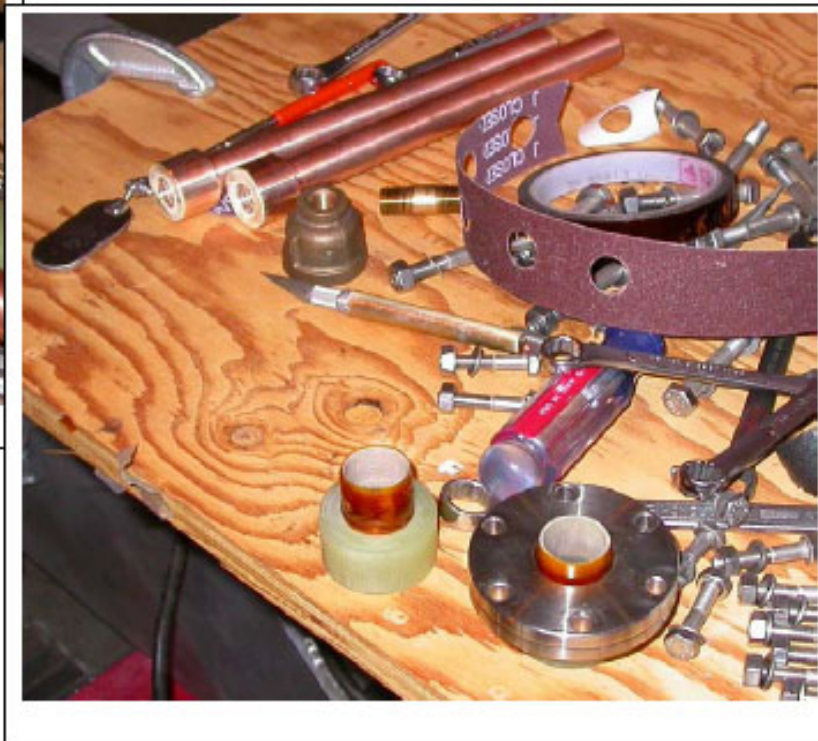
**I – Peter Titus – stripped the thread of one of the copper bar extensions while attempting to tighten it. We decided to inspect and re-work all threaded connections s needed.**

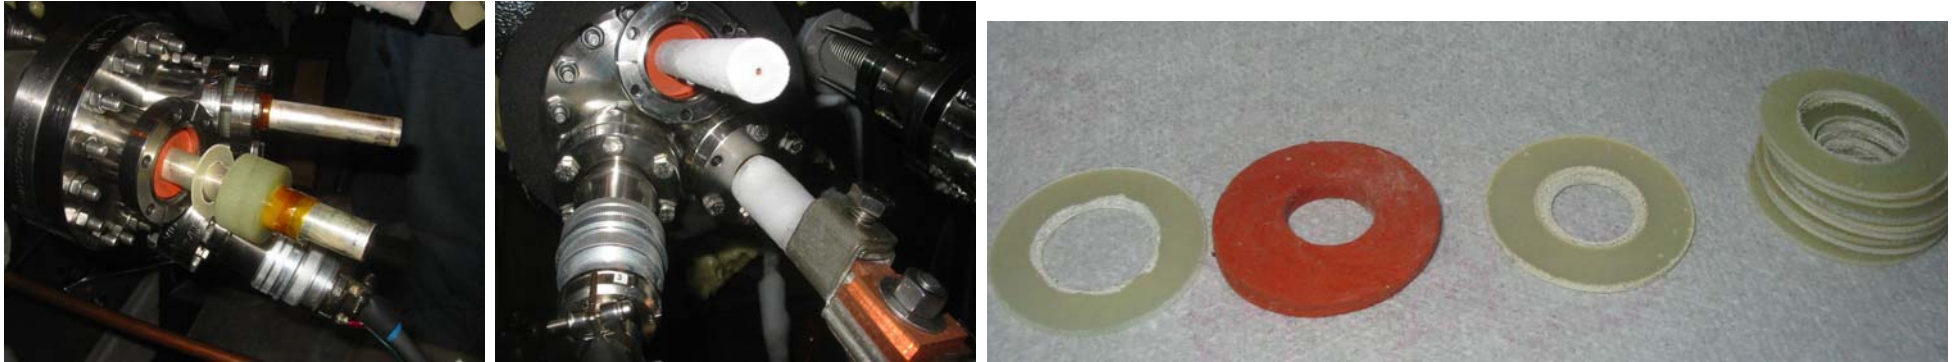
The gland seal of the copper leads is made via a stack of G-10 and silicone rubber.

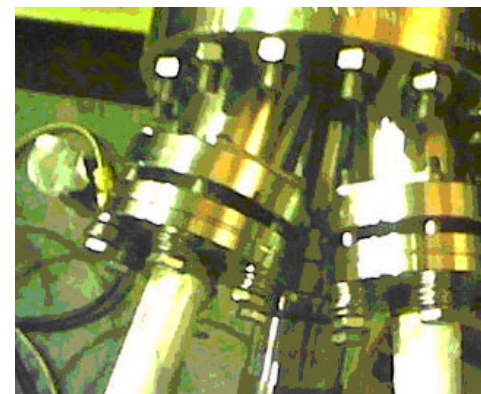
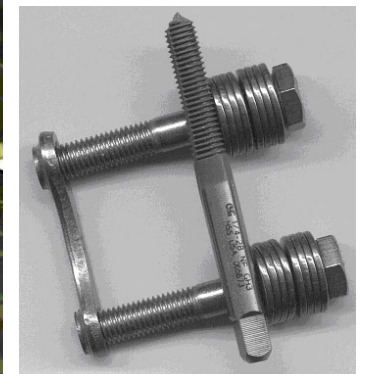
In March 2007 a 2nd silicone washer was added to each seal, and a Belleville washer stack added to provide compliance at both 77K and 300K.

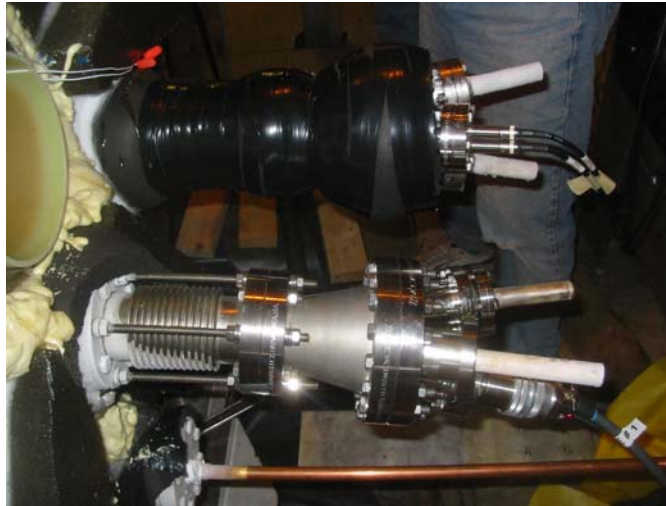
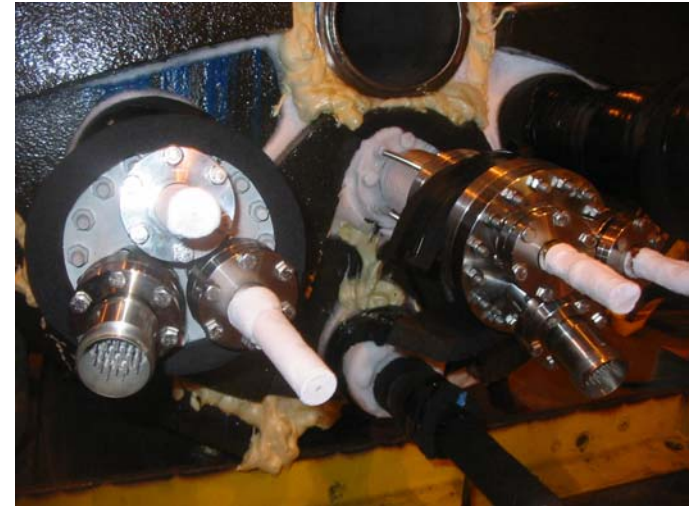
**MIT, 3 March 2007:**  
The inner coil lead is already bent slightly.

Concern is a possible short of the copper leads to the stainless steel jacket.

We will verify the integrity of the leads with a “hi-pot” test @ 1000 V.

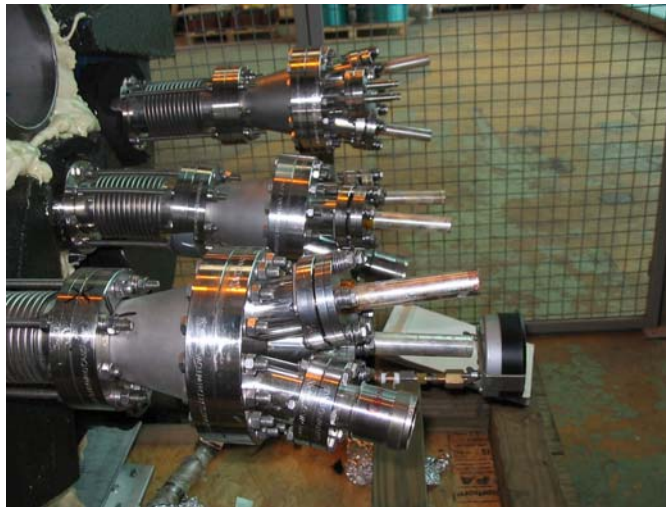
**CERN, 21 March 2007:**  
The inner coil lead may be bent more now.  
**Caution: “fisheye” distortion in close-up photo.**

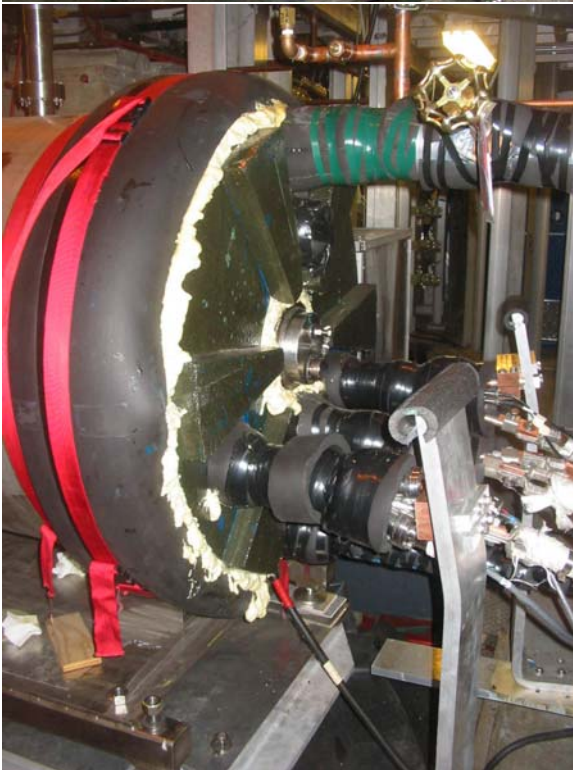
- **Cryostat vacuum jacket does not cover the endplate.**
- **The 0.8-m-diameter bellows next to the endplate, as well as the magnet leads, are covered in Armaflex insulation.** <http://www.armaflex.com/>  
Mold resistant AP/Armaflex Insulation is a flexible elastomeric thermal insulation and black in color. The expanded closed-cell structure of AP/Armaflex makes it an efficient insulation. It is manufactured without the use of CFC's, HFC's or HCFC's. It is also formaldehyde free, low VOCs, fiber free, dust free and resists mold and mildew.

- **Most of the flat endplate is covered in rigid Pittsburg-Corning Foamglas (noncombustible), which is bonded to the endplate with Stycast, an adhesive from Lakeshore Cryotronics.**  
<http://www.foamglasinsulation.com/literature/FI201.pdf>  
[http://www.lakeshore.com/temp/acc/am\\_epoxyts.html](http://www.lakeshore.com/temp/acc/am_epoxyts.html)

- **Gaps in the Foamglas insulation are filled with a spray-foam insulation, Dow "Great Stuff". This material is "flammable" but "fireblocking".**  
<http://greatstuff.dow.com/greatstuff/pro/sds.htm>  
<http://greatstuff.dow.com/greatstuff/pro/slideshow.htm>

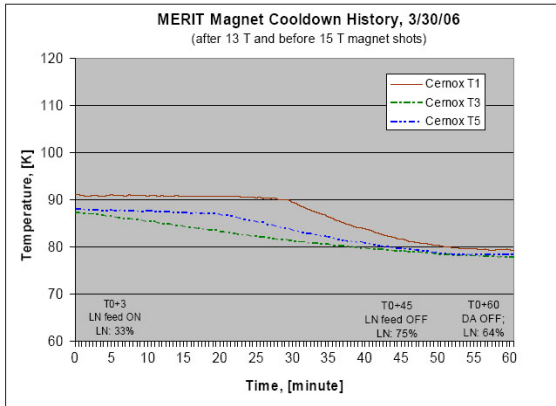
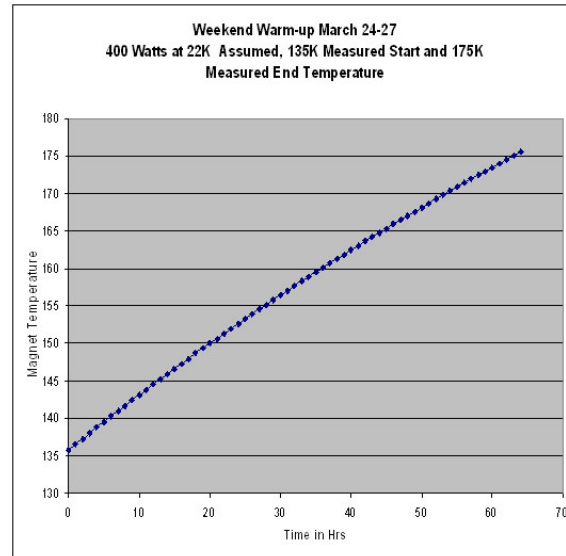
15K cooldown in 30 min.      3-day warmup  $\Rightarrow$  200 W heat leak.

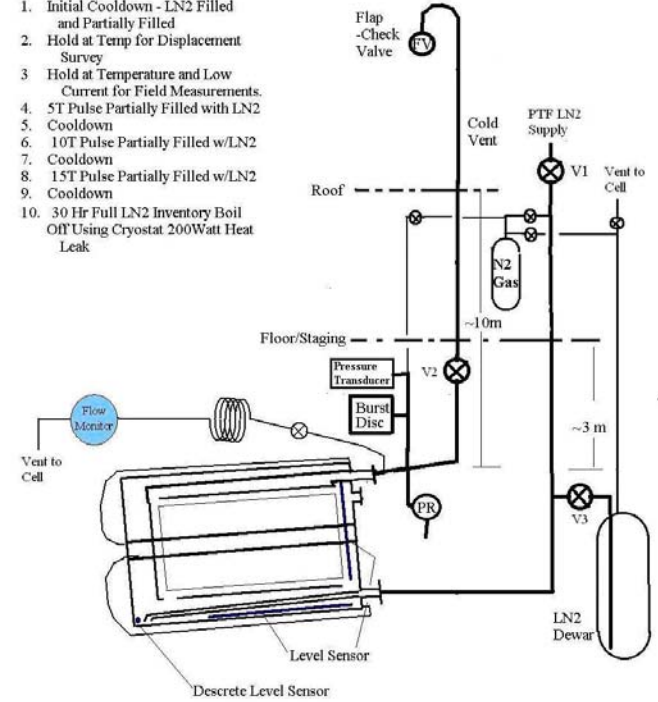
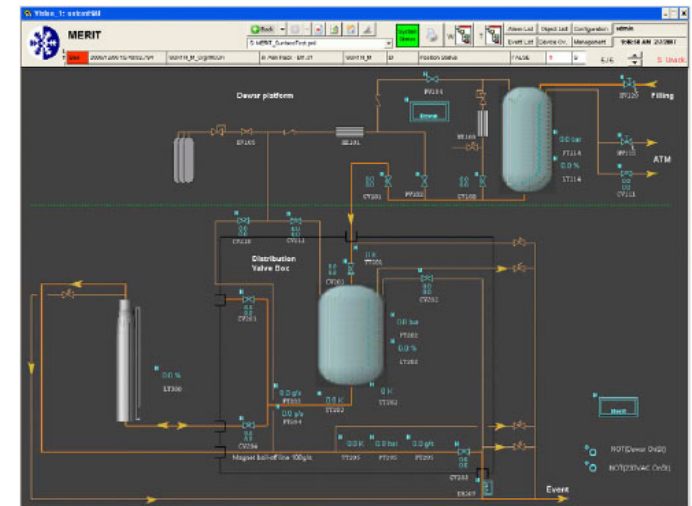
Full tests of the MERIT cryogenic system as coupled to the 15-T magnet will be performed in Bldg 180 at CERN prior to installation of the equipment in the TT2 and TT2A tunnels.

- Modes Of Operation
1. Initial Cooldown - LN2 Filled and Partially Filled
  2. Hold at Temp for Displacement Survey
  3. Hold at Temperature and Low Current for Field Measurements.
  4. 5T Pulse Partially Filled with LN2
  5. Cooldown
  6. 10T Pulse Partially Filled w/LN2
  7. Cooldown
  8. 15T Pulse Partially Filled w/LN2
  9. Cooldown
  10. 30 Hr Full LN2 Inventory Boil Off Using Cryostat 200Watt Heat Leak
