# MERIT Installation at CERN

K. McDonald

For the MERIT Collaboration

April 13, 2007

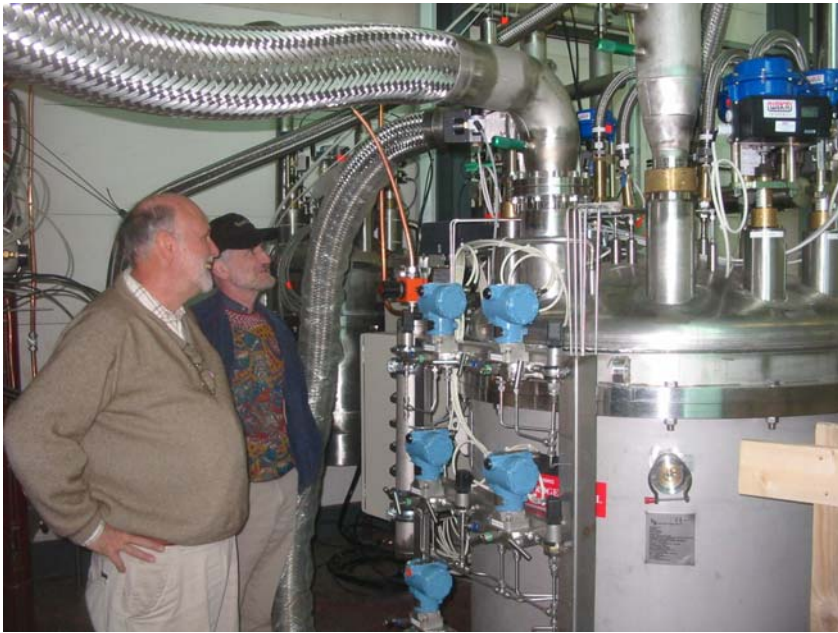
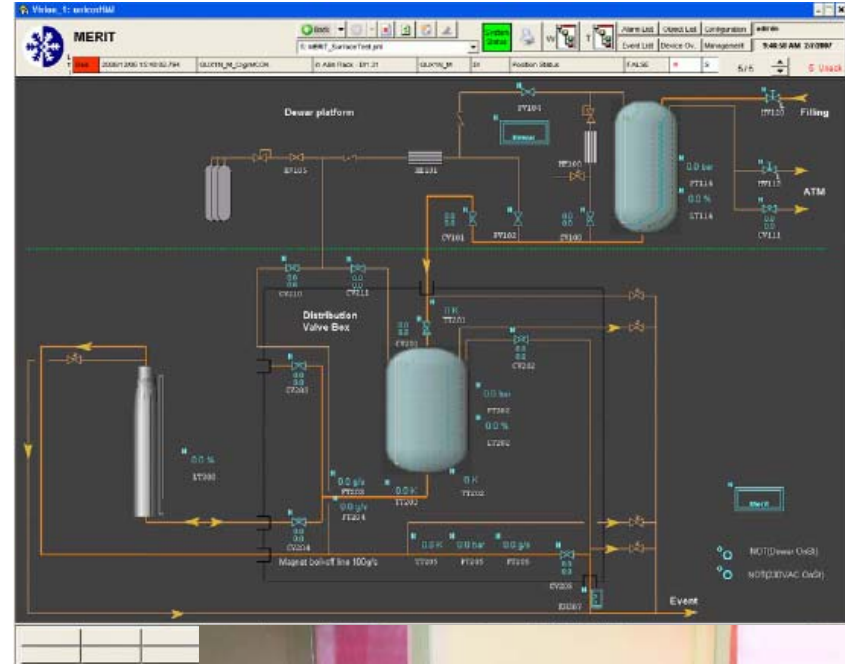
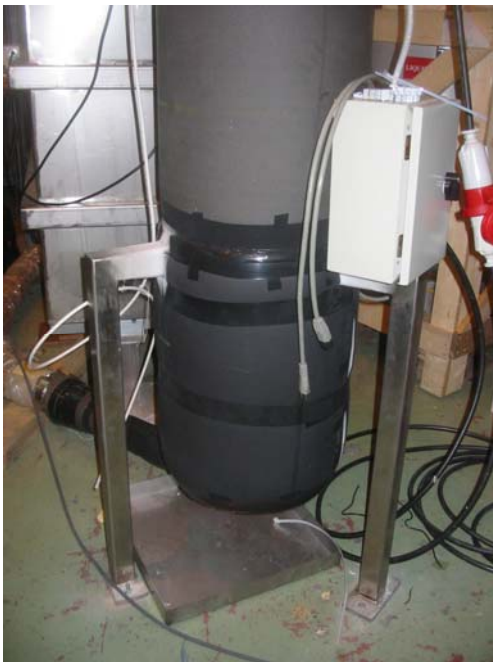
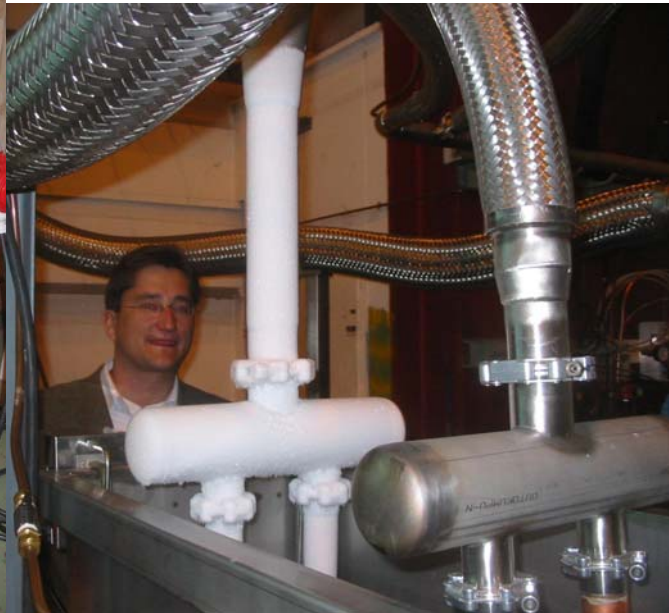
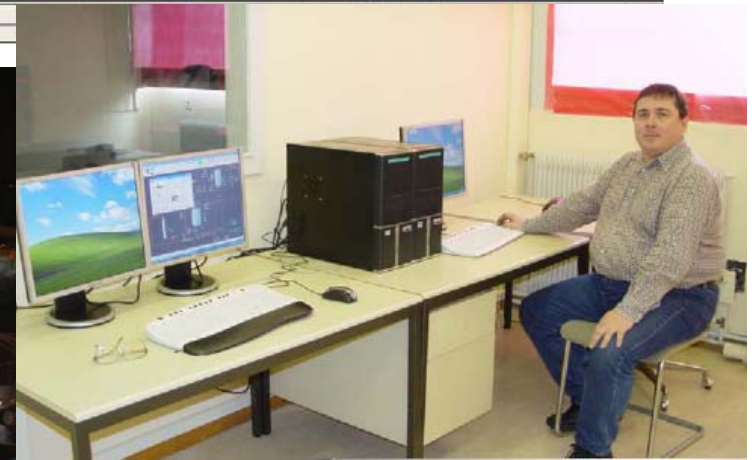
# Cryo System Exercised in Bldg 180 via Control from Bldg 272

Test magnet with cryo system in Bldg 180 starting 10 April.

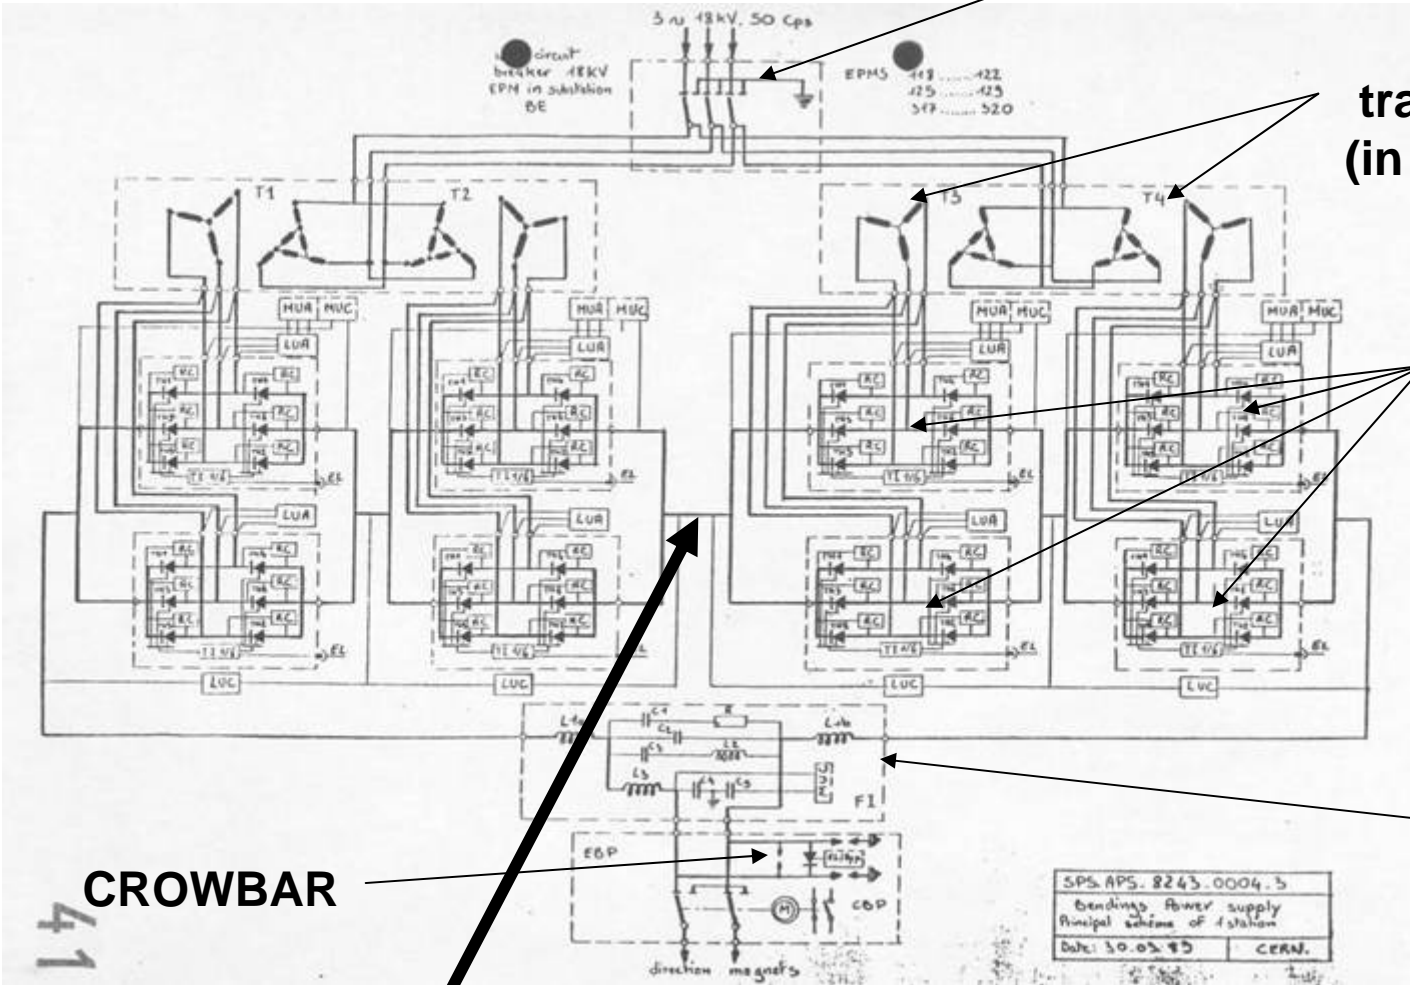
# West Area power converter 8000A<sub>dc</sub>, 1000V<sub>dc</sub>

Connect midpoint of power supply to ground thru 1Ω, so magnet runs at ±350 V.
