Surface Inspection of the MERIT Primary Containment Chamber

*Van B. Graves
Oak Ridge National Laboratory
December 29, 2011*

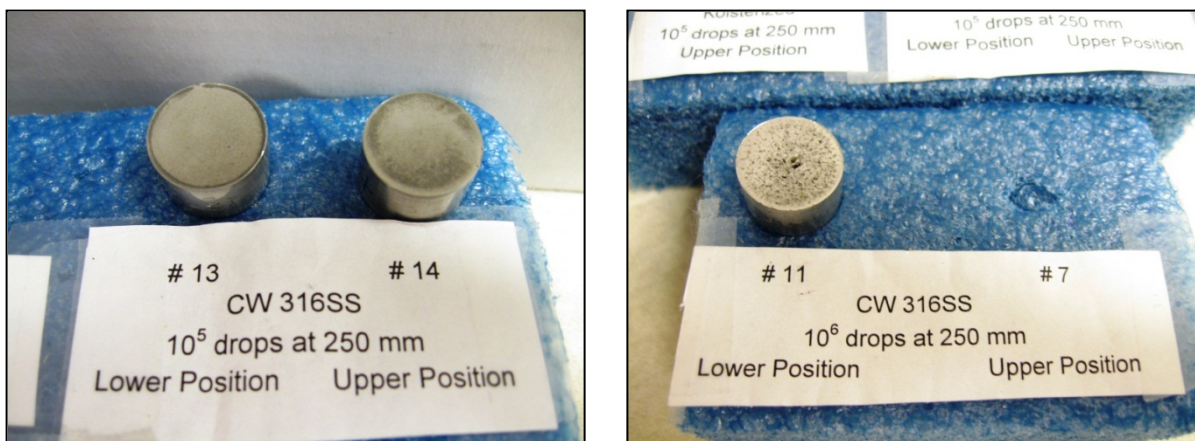
Figure 7. SNS cavitation study samples.

In preparation for the measurement of the MERIT surfaces, it was desired to gain experience with the Handysurf data collection sequence by scanning the surface of some known specimens. ORNL's Spallation Neutron Source (SNS) Project has had a mercury target development program in place for several years and has performed numerous studies related to cavitation-induced surface pitting. In one such study, specimens were placed within a Split-Hopkinson Pressure Bar apparatus and subjected to varying numbers of pressure cycles, some up to 10⁶. These cycles produced surface textures with varying degrees of pitting, as shown in Figure 7. In all cases, the specimens had quantified surface finishes prior to the experiment.

with the photograph in Figure 7, several of the large surface pits visible to the eye can be identified in the profile and roughness curves.

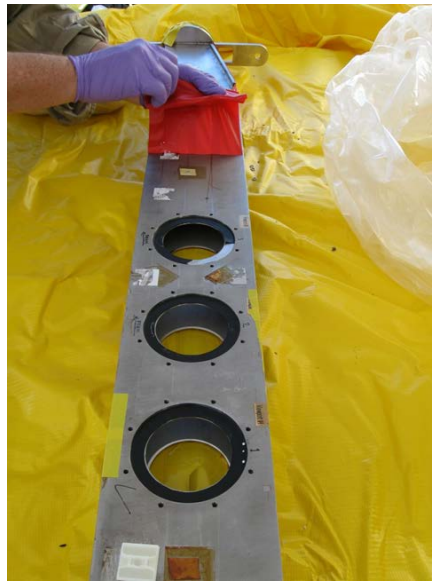
Figure 10. MERIT primary containment chamber.

Figure 7 shows the MERIT primary jet containment chamber being uncovered for the inspection by the Handysurf. Viewports 1-3 are shown, with viewport 1 at the bottom of the image. Both exterior and interior scans were made with the device; the exterior scans were on the exposed surface shown in the figure, and the interior scans were on the bottom interior surface.

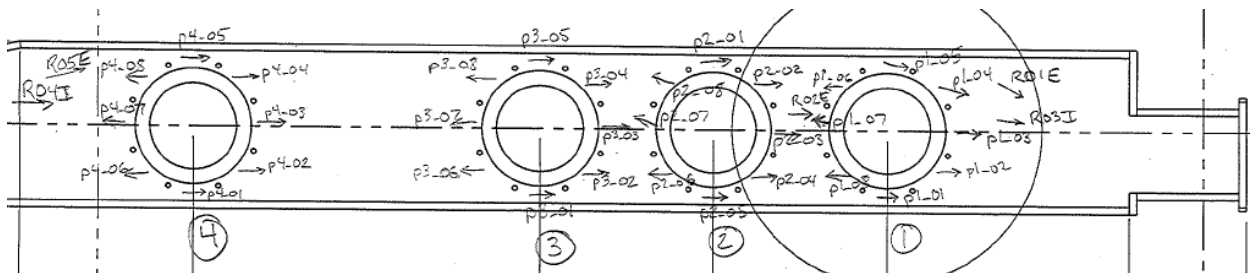
Figure 11. Scan map.

A map of the scans performed is shown in Figure 8. In this figure, the viewports are sequentially number right-to-left. All the viewport scans are labeled Px_yy, where x is the port number, and yy is the scan number. Each viewport was scanned in eight areas, and the direction and approximate location of each scan being shown in the figure.

A more interesting observation can be made when the viewport #2 scans are compared to other locations on the same interior surface, which can be seen in Figure 15. From the scan map shown in Figure 11, it is seen that the R04 scan was taken downstream of viewport #4, well outside the area where any kind of damage-inducing droplets would be expected. It is noteworthy that no distinguishable differences exist between the scans around viewport #2 and this downstream location.

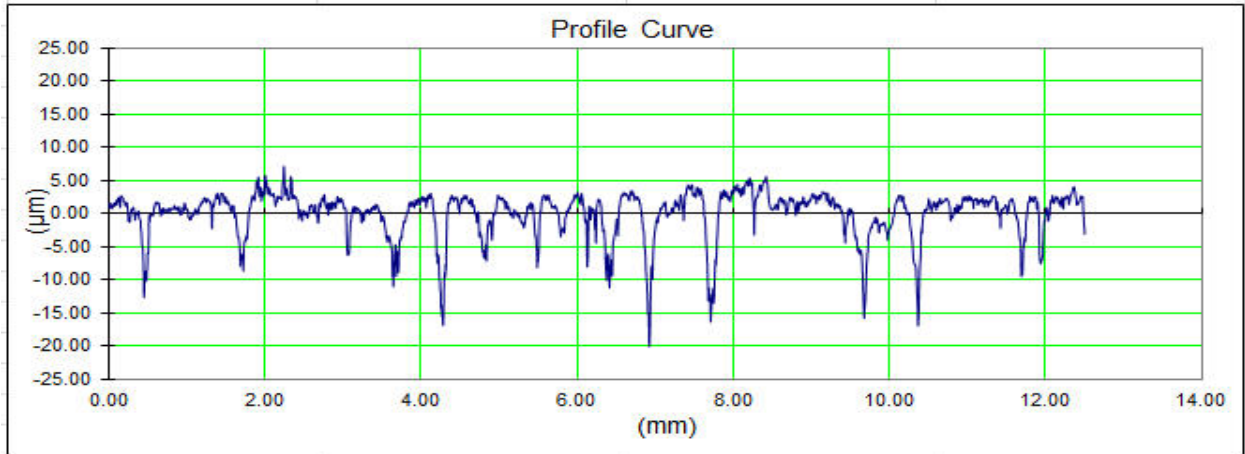
Figure 17. Scan R01 profile (exterior surface).

As another point of comparison, the profile from measuring an exterior surface of the MERIT chamber is shown in Figure 16. This surface was machined to final dimension, and the improved flatness of the surface can be seen in the figure. It is noted that even this machined surface shows local deviations of 10-20 μm , so even if mercury droplets could have impacted and damaged this surface, it would be

difficult to distinguish from surface imperfections. So the relative roughness of the interior surface is not surprising, considering it had no machining or other surface preparation prior to fabrication.

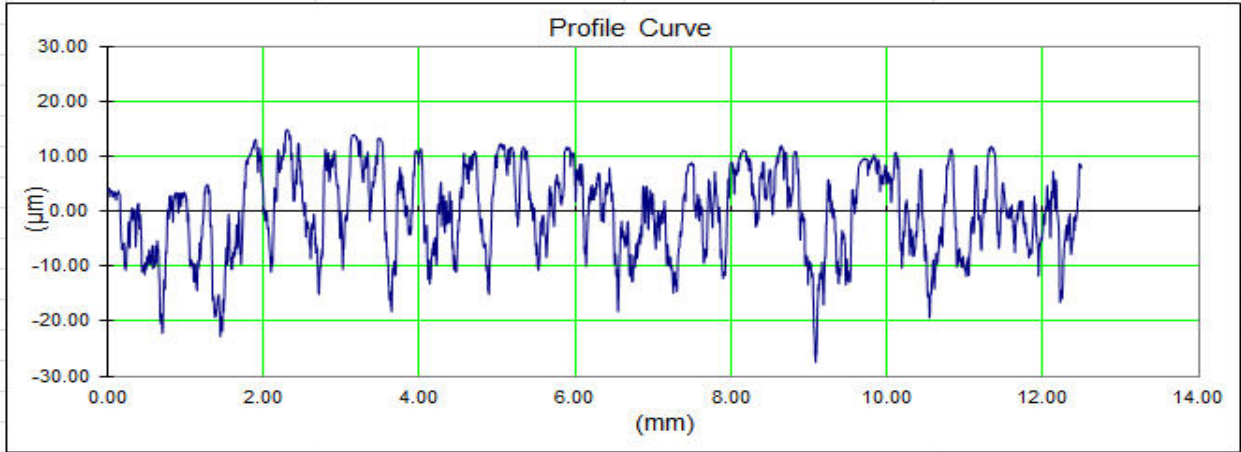
Figure 32. Scan P2_03 profile.

All the scans taken of the MERIT jet primary containment chamber are included in the Appendix. Of the most interest were the scans performed around viewport #2, which was centered on the jet/beam interaction location. Of the eight scans performed around viewport #2, scans 3 and 7 were along the beam axis and would be the most likely scans to show indications of surface damage. The profile curves produced from these scans are shown in Figures 13 and 14.

Comparing these profile curves with the photographs of viewport #2 shown in Figure 5, the apparent texture in the photographs can be observed in the scan data. It is also noted that the two curves are similar in that their deviation ranges are between $\pm 10 \mu\text{m}$, which indicates the same overall surface condition. A review of the other viewport 2 scans in the Appendix reveals very similar surface profile curves.
